CHICHEN ITZA

ARCHITECTURAL NOTES AND PLANS

Karl Ruppert

Publication 595

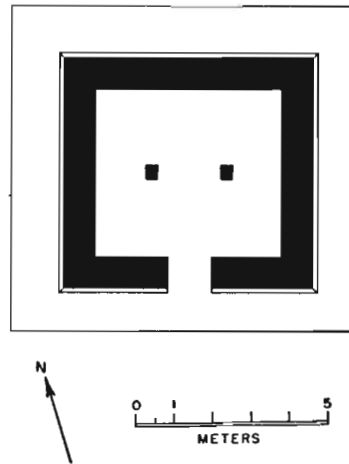
FIG. 84—STRUCTURE 5C3, PLAN

Condition: Traced on four sides of the structure. It is an independent terrace rising from that of the Initial Series Group.

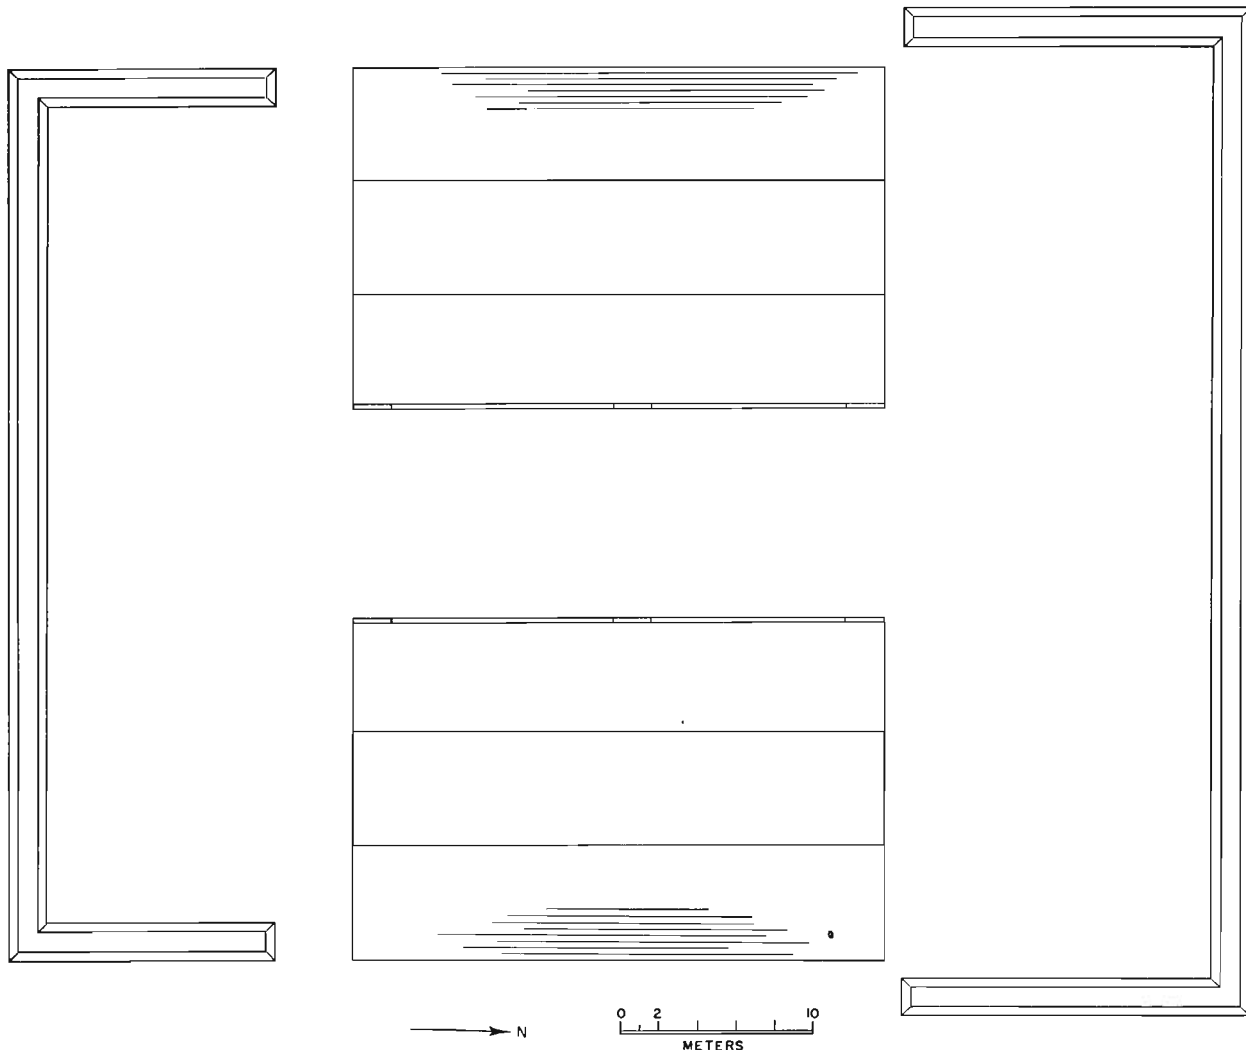
FIG. 112—FAR EAST GROUP: BALL COURT, PLAN

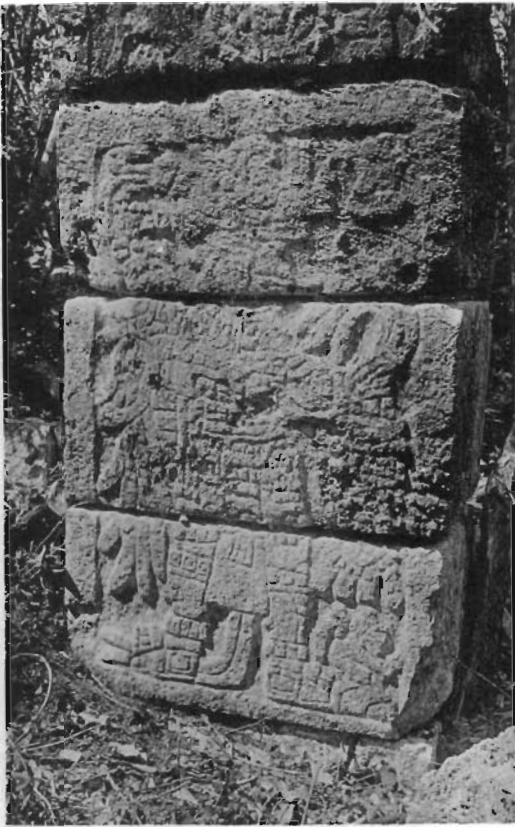
a

FIG. 117—STRUCTURES 2B2, 2C1, AND 2C3
a: Str. 2B2, north face of south column. *b*: Str. 2C3, south column. *c*: Str. 2C1, north column sculptured in low-relief serpent. Roof ornament in form of rattles. *d*: Str. 2C1, standard bearer.

angular molding. Triple entrance. Two columns 57 by 80 cm. South column has five blocks in position. Columns sculptured on four sides with human figures. Human figure (fig. 117,a) panels 1.08 m. high. Feet point outward; long nose-bead worn. Jambs 80 cm. wide, formed of large horizontal blocks with concavity in back. Sculpture similar to columns.

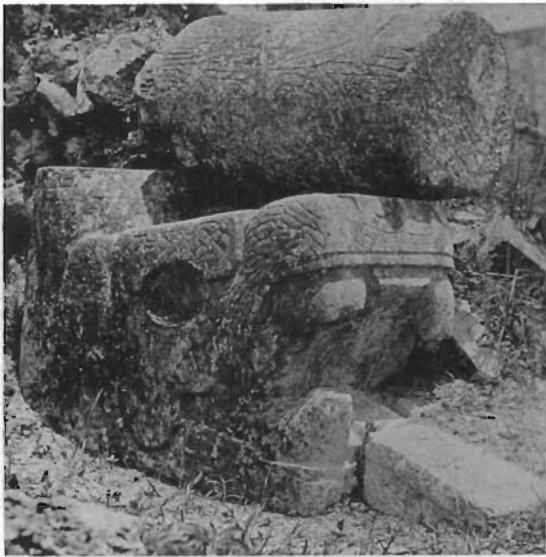
a

FIG. 119—STRUCTURES 2D7 (TEMPLE OF THE BIG TABLES), 3B4, AND 3C1 (HIGH PRIEST'S GRAVE)
a: Str. 2D7, head and drum of serpent column. *b*: Str. 2D7, south jamb of inner doorway. *c*: Str. 3B4, portion of kneeling figure.
d: Str. 3C1, base of east stairway.

Façade: Basal batter rises 1.26 m., topped with 20-cm. triangular molding. Triple entrance, two serpent columns, 56 cm. diam. (fig. 119,a). One tail on top

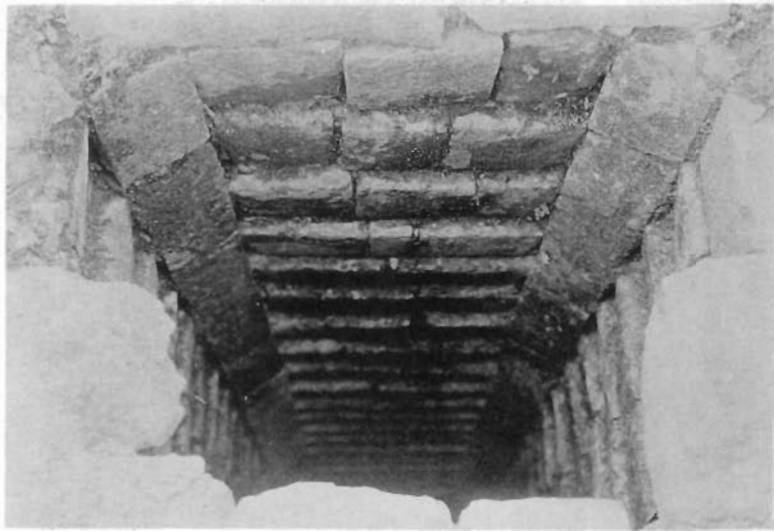
a

FIG. 120—STRUCTURE 3C1 (HIGH PRIEST'S GRAVE)
a: Top of shaft. *b*: Sculptured stone and seated figure. *c*: Seated figure. *d*: Standing figure.

Shaft: Orifice (74 cm. square) of stone-lined shaft in floor of chamber between two east columns (fig. 120,a). Shaft extends downward to approximate level of base of pyramid where it opens in top of natural cavern.

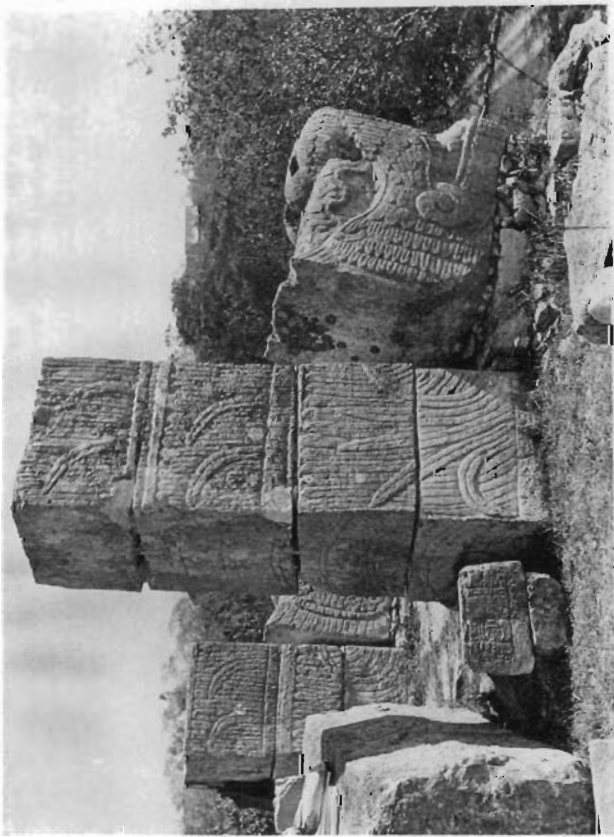
FIG. 121—STRUCTURE 3C1 (HIGH PRIEST'S GRAVE)
a: Serpent columns. *b-l*: Miscellaneous stones sculptured with hieroglyphs; found on top of pyramid.

Façade: Basal batter rises 1.75 m. Batter of south jamb of east doorway attains this height with a single stone. Triple entrance, two serpent columns 66 cm. square (fig. 121,a). Tails, weathered and broken, are at base of pyramid.

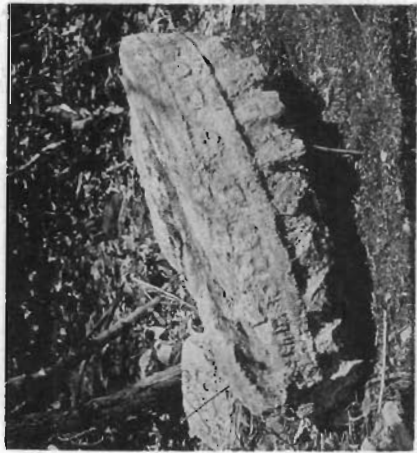
f

FIG. 122.—STRUCTURES 3C6 (TEMPLE OF THE INTERIOR ATLANTEAN COLUMNS), 3C7 (HOUSE OF THE DEER), AND 3C8
 a: Str. 3C6, interior Atlantean columns. b: Str. 3C7, collapsed vault, east chamber. c: Str. 3C8, large stone on paved way leading north
 of Str. 3C8. d: Str. 3C8, stone drum and masonry foundation located in center of platform. e: Str. 3C8, stone ring found on platform.
 f: Str. 3C8, semicircular carved stone found on platform.

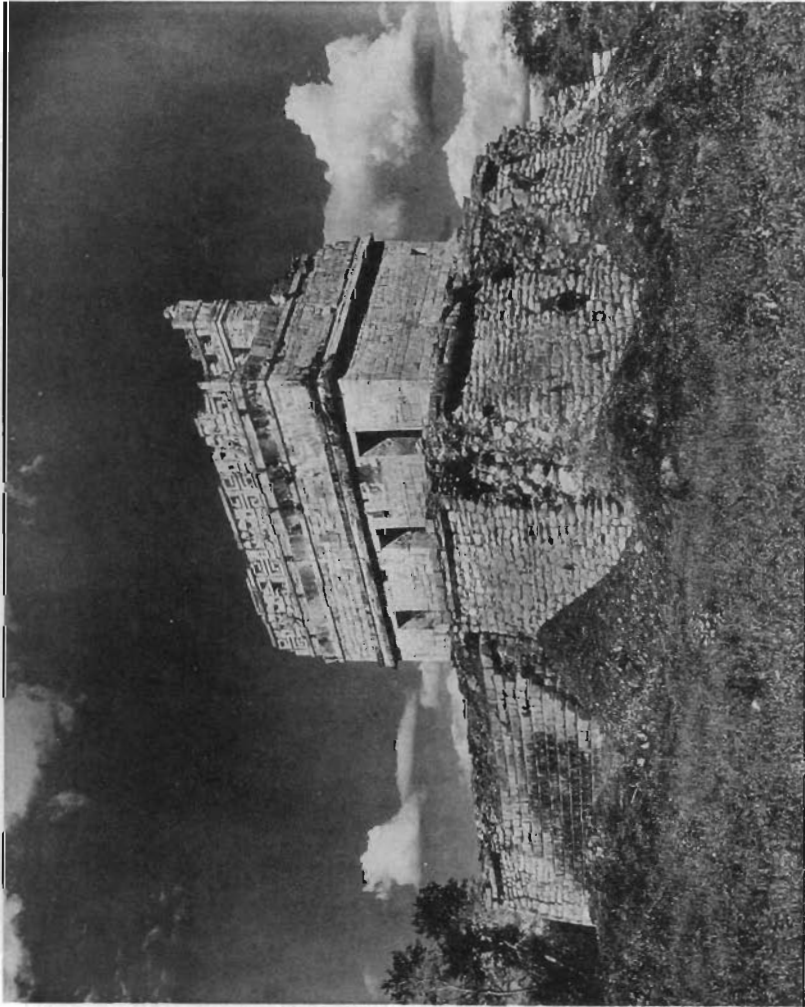
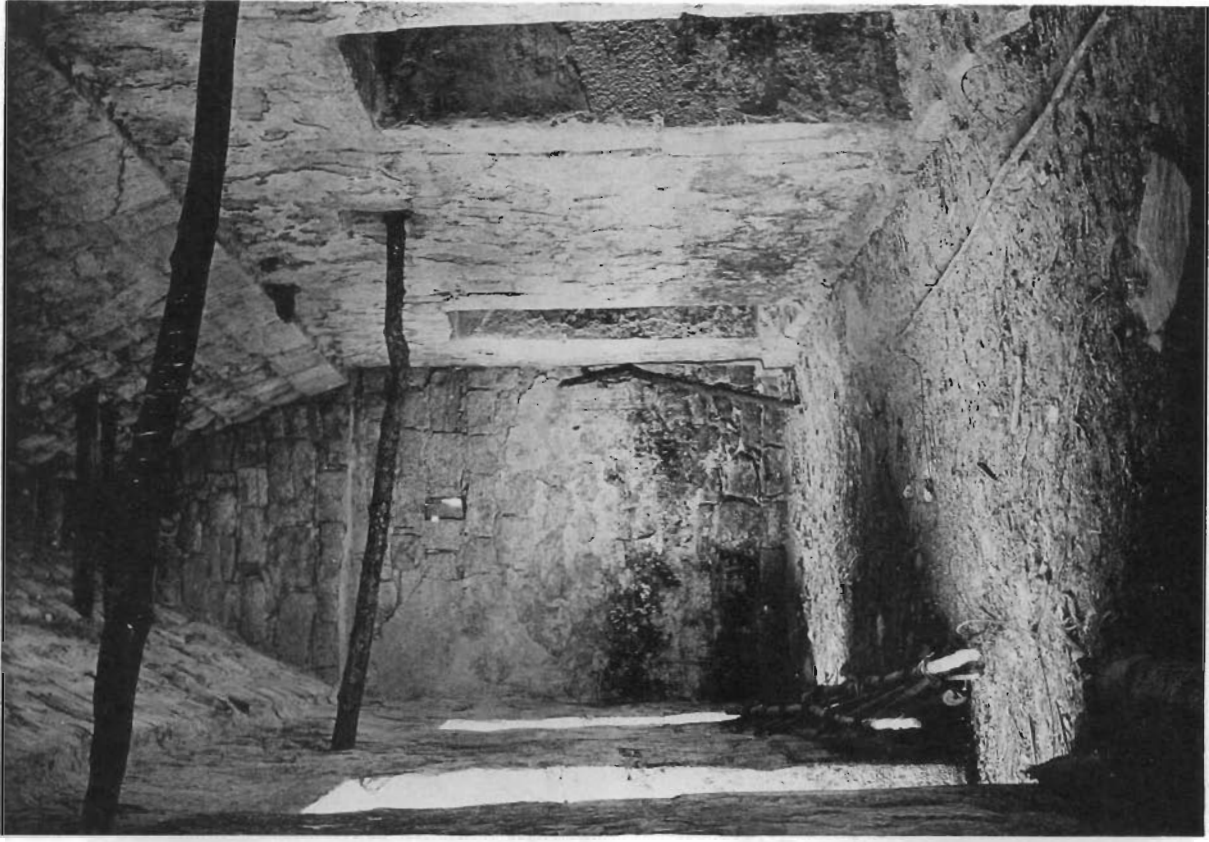
FIG. 123—STRUCTURE 3C9 (THE RED HOUSE)
a: View from southwest. b: Interior, north end of outer chamber.

FIG. 30—STRUCTURE 3C9, PLAN AND ELEVATION
a: Plan. *b*: West elevation of building (see fig. 123).

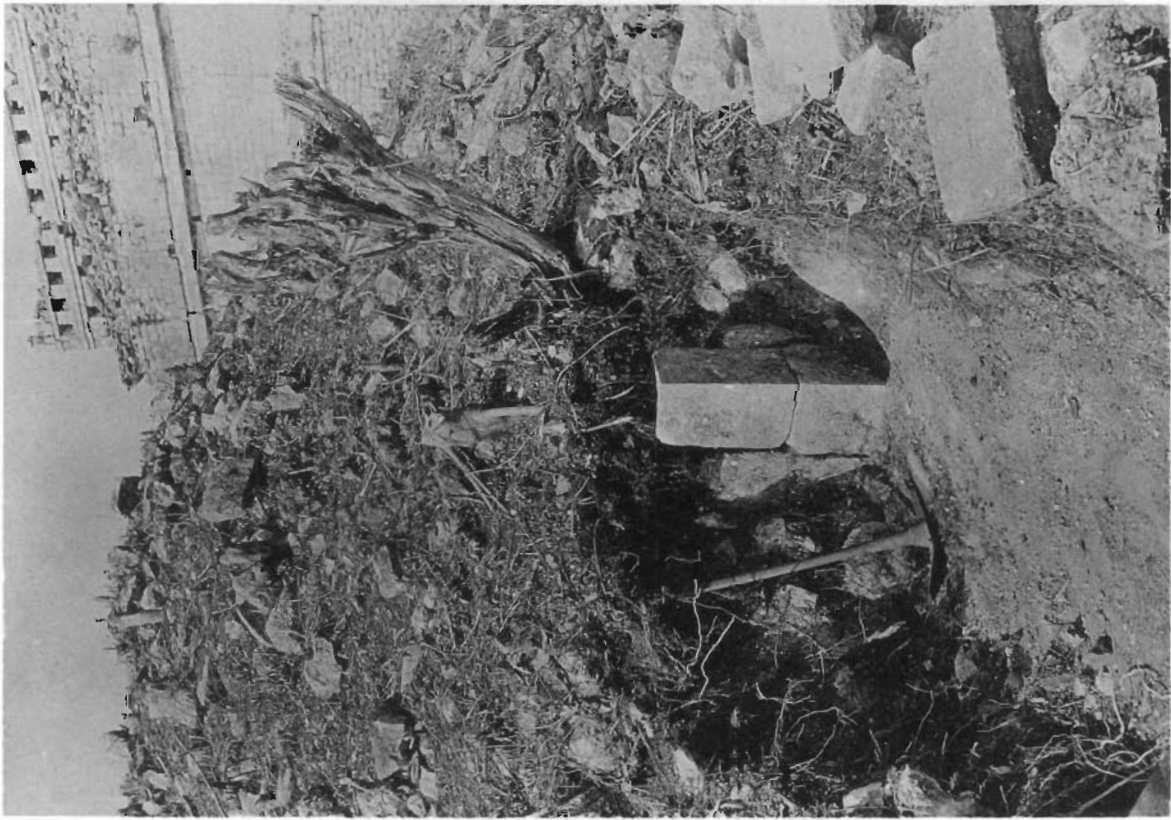
a

FIG. 124—STRUCTURE 3C10 (RED HOUSE BALL COURT)
a: Northeast corner east range. *b*: East bench, center panel. *c*: West bench, center panel.

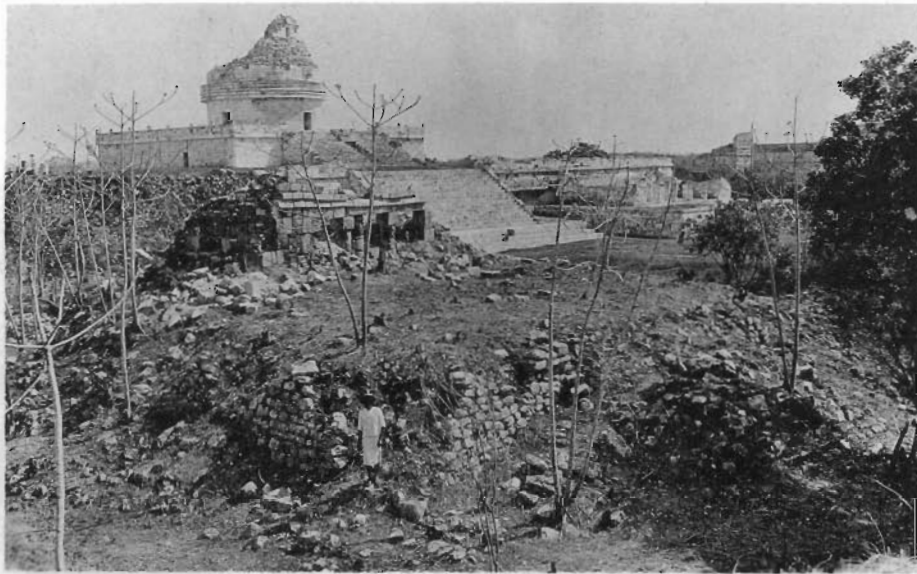
a

FIG. 125—STRUCTURE 3C11 (MAUDSLAY'S NO. 6)
a: General view of platform and building from northwest. *b*: The building, west side. *c*: Interior, northwest corner, showing vault stones and sculptured stone re-used in wall.

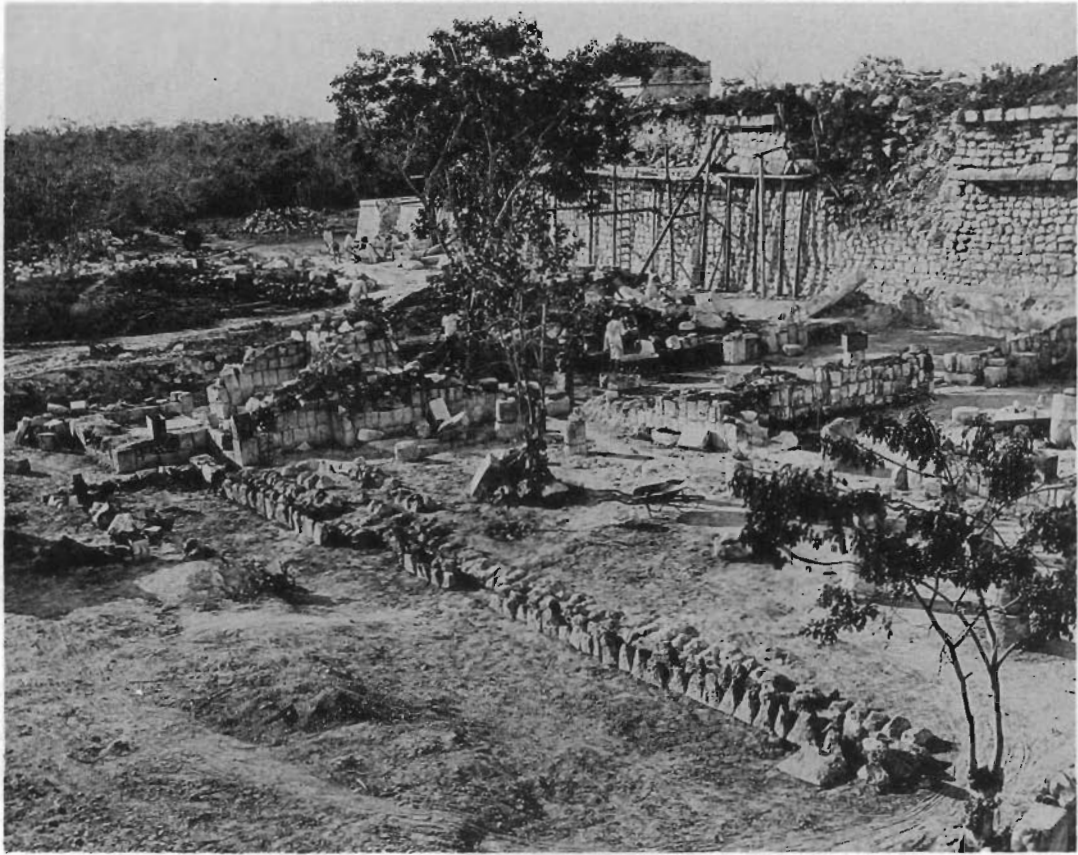
FIG. 126—STRUCTURE 3C15 (CARACOL SOUTH ANNEX, EAST BUILDING)
a: Section of molding lying face downward to south of building. *b*: Altar and column in southeast room. *c*: Sculptured jamb stones.

Lying 3.15 m. south of the columns was a section of molding 16 m. long (fig. 126,a). The stones of the molding were face downward. Some wall stones to the north. Lower member of molding 16 cm., the band 12 cm., the cornice 40 cm.

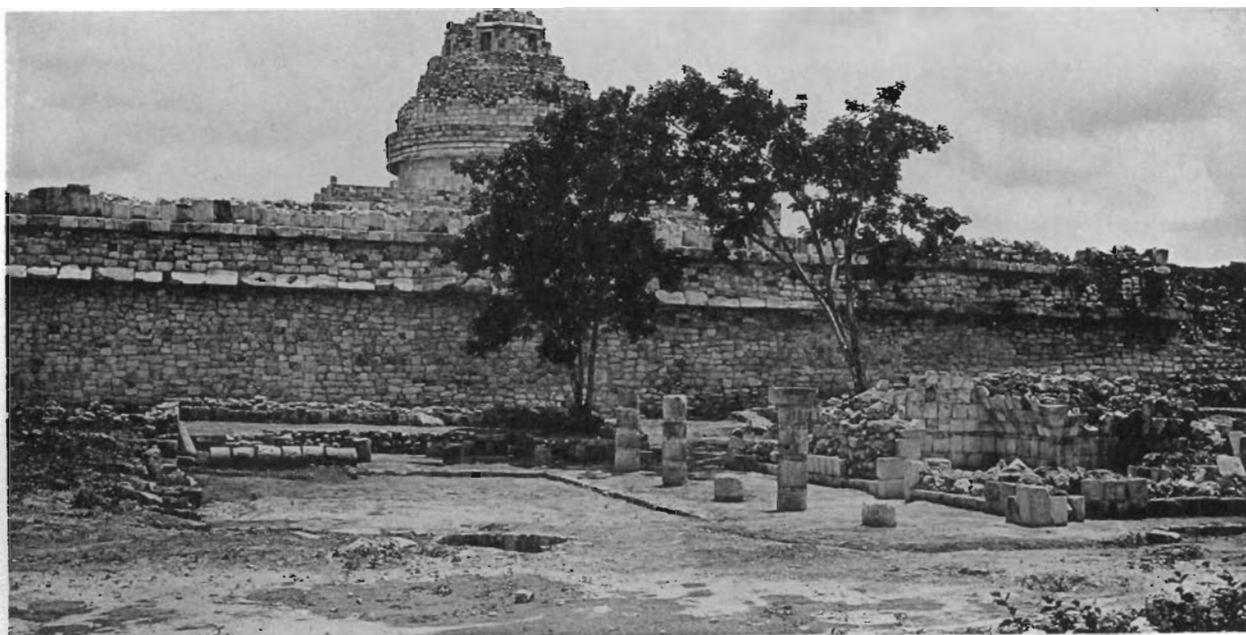
a

FIG. 127—STRUCTURE 3C15 (CARACOL SOUTH ANNEX, SWEAT HOUSE)
a: General view from southwest. b: Interior looking north. c: Exterior northeast corner, section of molding *in situ*.

Façade: Rises vertically. Five columns 43 cm. diam. (fig. 127,a). Only one rectangular capital found.

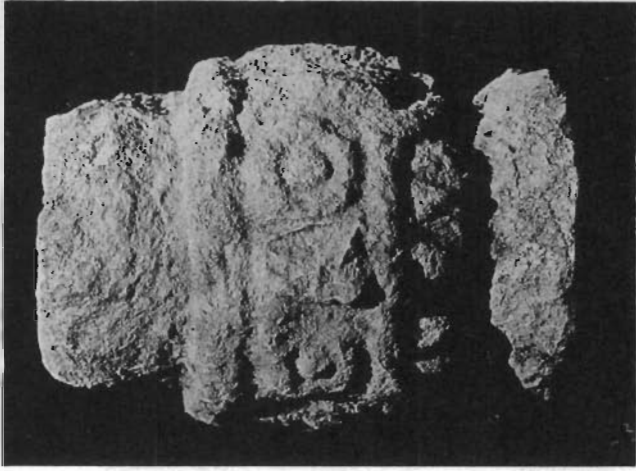
b

FIG. 128—STRUCTURE 3C15 (CARACOL SOUTH ANNEX, BENCH HOUSE AND WEST COURT)
a: Bench House, stone head found on floor northwest corner. b: Bench House, stone Tloloc head found on floor southwest corner.
c: West Court, circular paved area and drain. d: West Court, cistern.

On floor at south end of east bench were two sculptured stones such as are used in headbands over masks. They were carved with link and feather designs. At southwest corner a stone Tlaloc head, not over 20 cm. high (fig. 128,b).

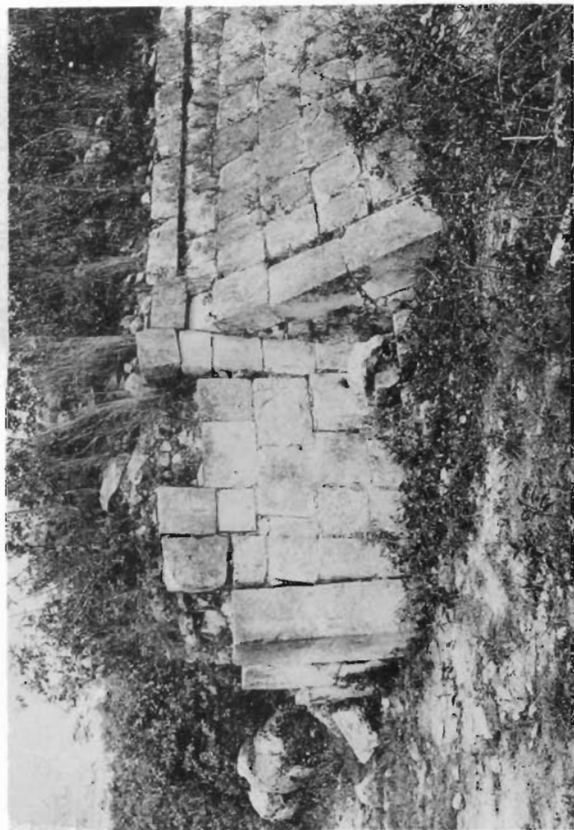
FIG. 129—STRUCTURES 3D1 (WEST COLONNADE) AND 3D4
a: Str. 3D1, north side of east passage. b: Str. 3D4, two ranges of ball court. View from northeast. c: Str. 3D4, south face of bench in north room, top of east range. d: Str. 3D4, west face of bench in north room, top of east range.

East passage: Located 59 m. south of junction of West Colonnade with Northwest Colonnade (fig. 129,a), 2.50 m. wide. Top vaulted. Floor of plaster to east side of wall, then flagstones which gradually slope downward as a ramp 1.30 m. long to the level of the plaza floor.

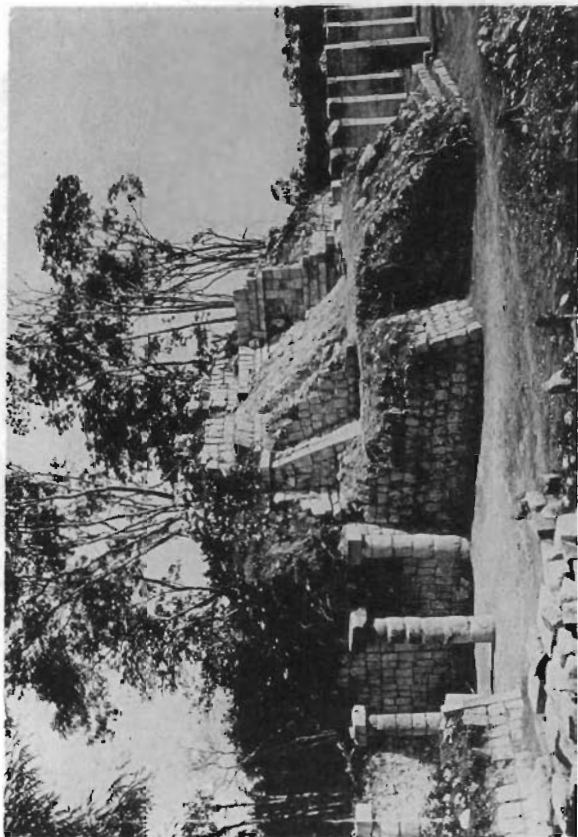
b

FIG. 130—STRUCTURES 3D5, 3D6, AND 3E1 (NORTHEAST COLONNADE)
a: Corner where Sts. 3D5 and 3E1 join. b: Stairway at west end of Str. 3E1 and portion of Str. 3D6. c: West end of Str. 3E1 and portion of Str. 3D6, looking west.

shield as one of the elements of decoration in the upper zone, and the final three-member molding (fig. 130*b*).

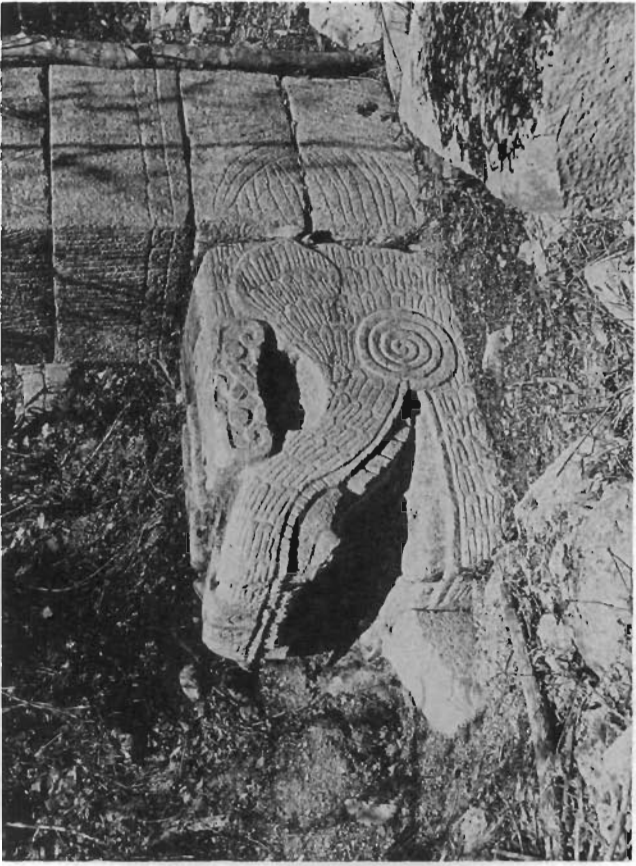
b

FIG. 131—STRUCTURE 3D8 (TEMPLE OF THE LITTLE TABLES)
a: North column of outer chamber. b: North serpent column. c: Chac mool figure.

Serpent columns 68 cm. square (fig. 131*b*). North column, on back, shows two sets of cordholders 55 cm. above floor. South column has one set of cordholders in middle of back, 2.15 m. above floor.

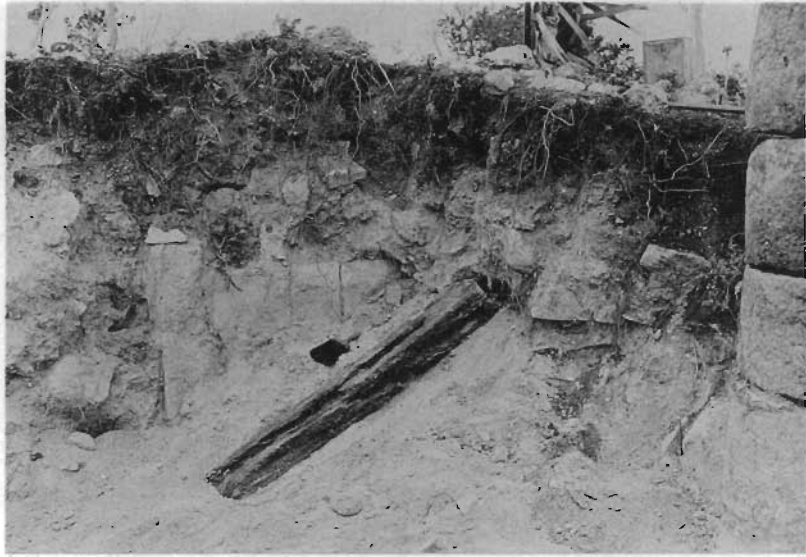
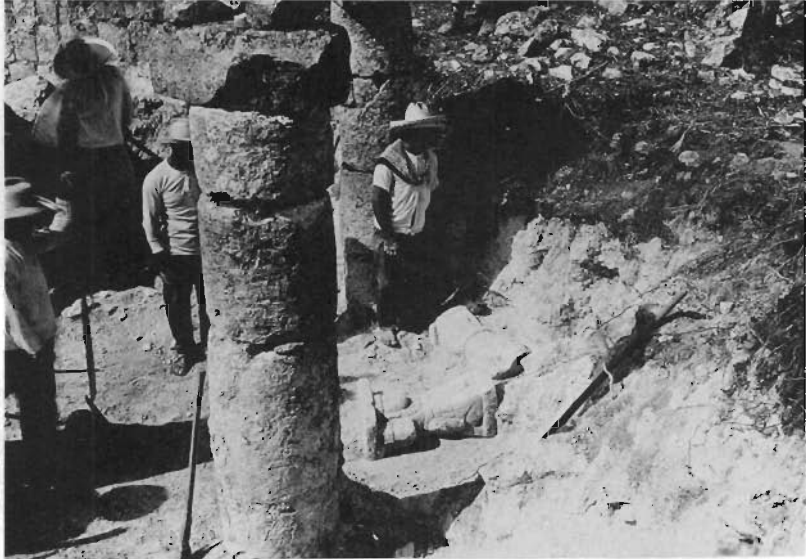
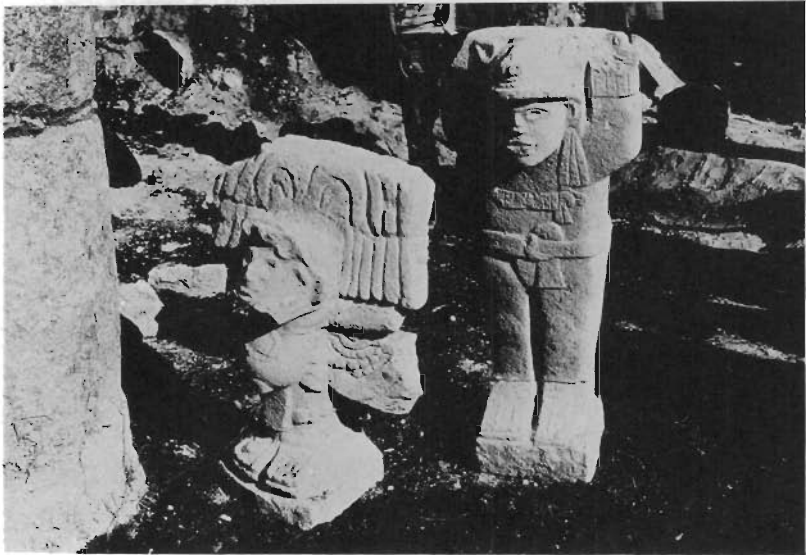
FIG. 132—STRUCTURE 3D10 (SOUTHEAST COLONNADE), ROOM C
a: Remains of wooden beam. b,c: Atlantean figures.

Area C: Remains of wooden beam in poor state of preservation found in debris east of north doorway. Perhaps lintel of doorway (fig. 132,a). Beam 1.43 m. long, 18 cm. wide, 14 cm. thick. East end 1.20 m. from east jamb and 80 cm. above floor. West end 40 cm. above floor. Vaults extended north and south. Atlantean figures: Five found east of west doorway; none *in situ* (fig. 132,b,c). Two found in west vault area, three in middle vault area.

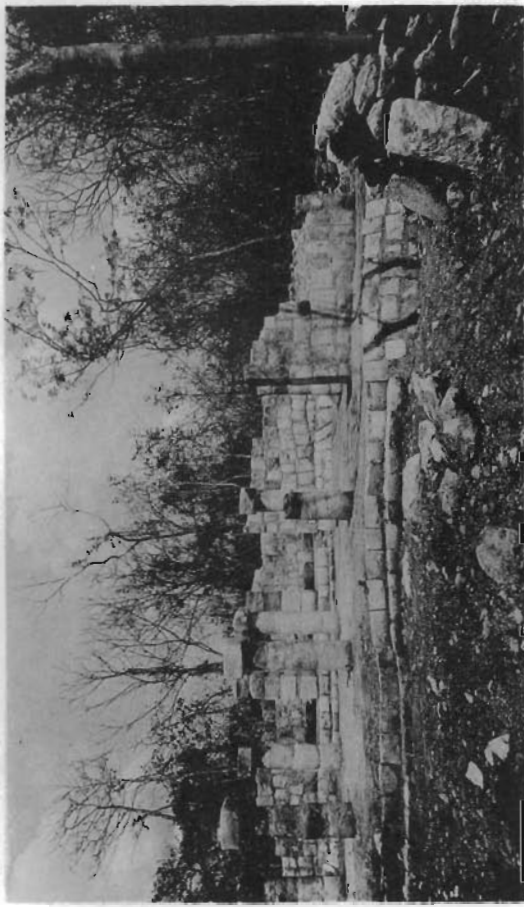
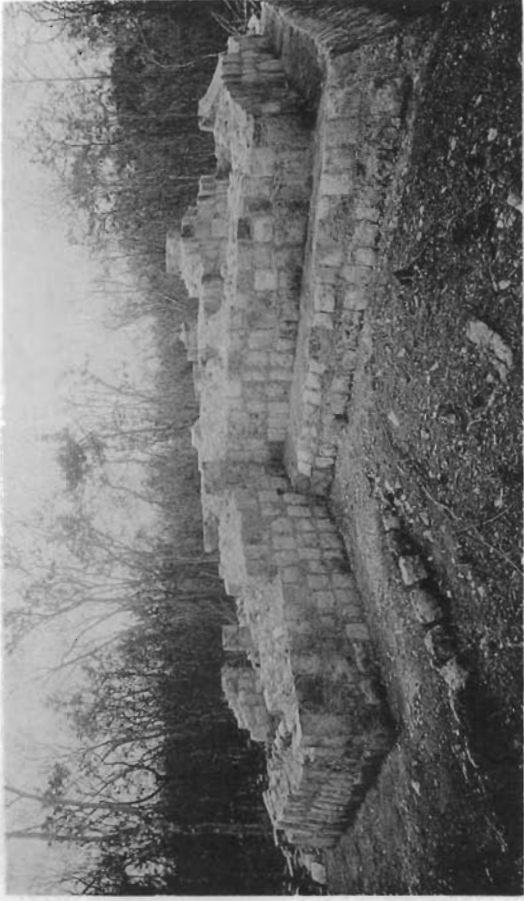
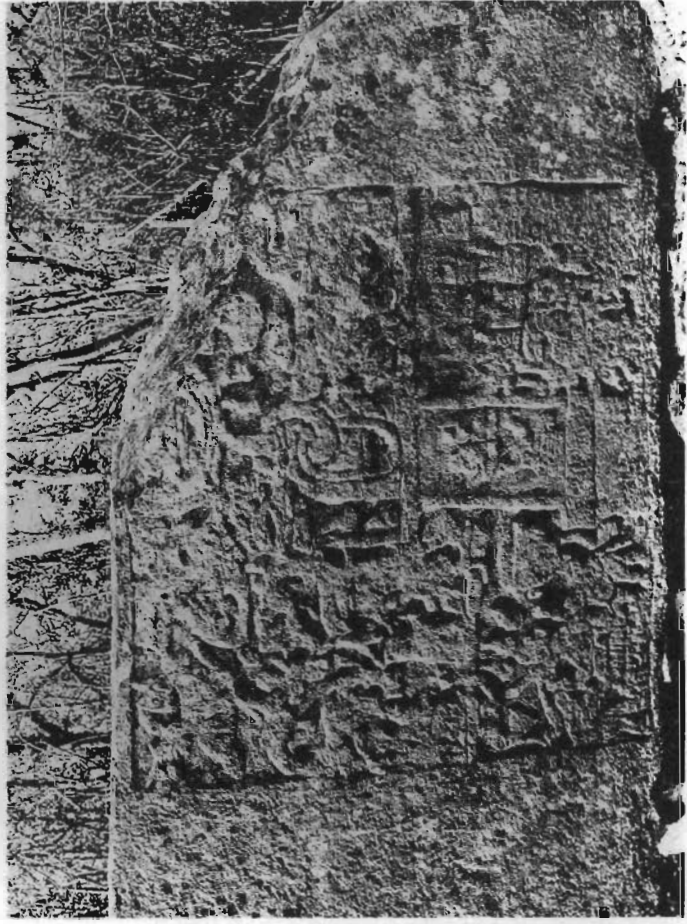
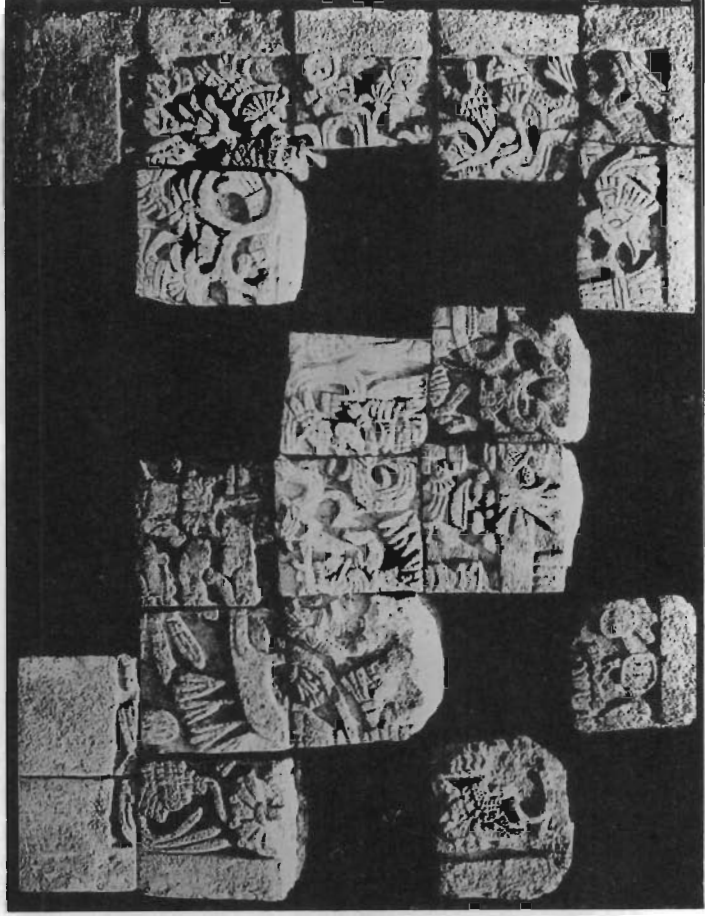
FIG. 133—STRUCTURE 3D13 (XTOLOC TEMPLE)
a: West side. *b*: View from southeast after excavation. *c*: Sculptured lintel. *d*: Sculptured panel from vault of shrine room.

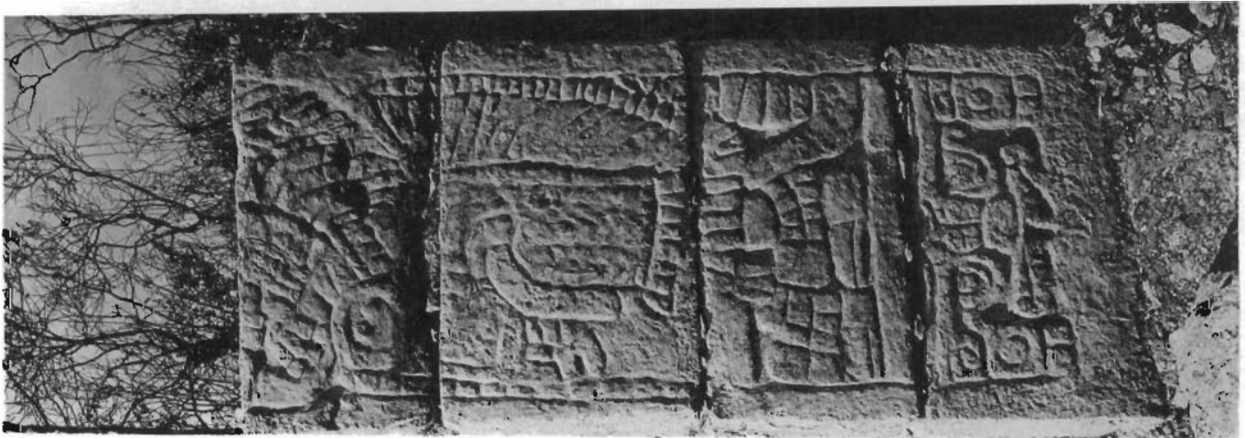
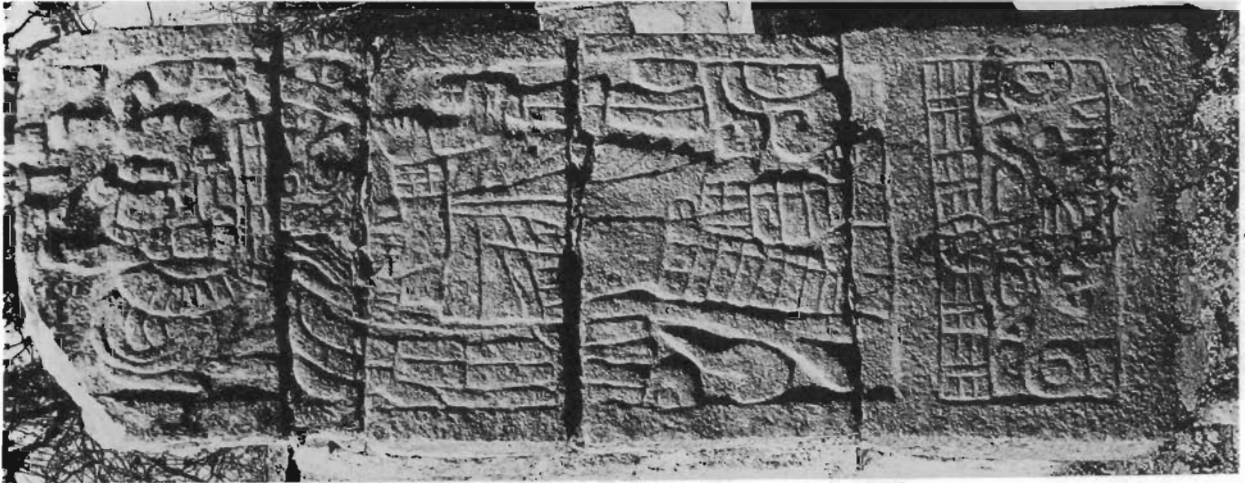
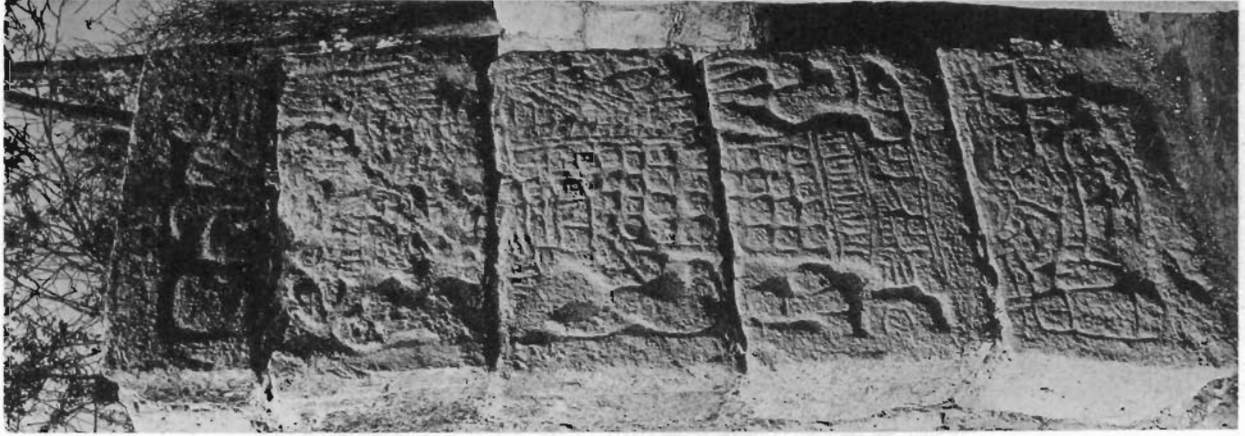
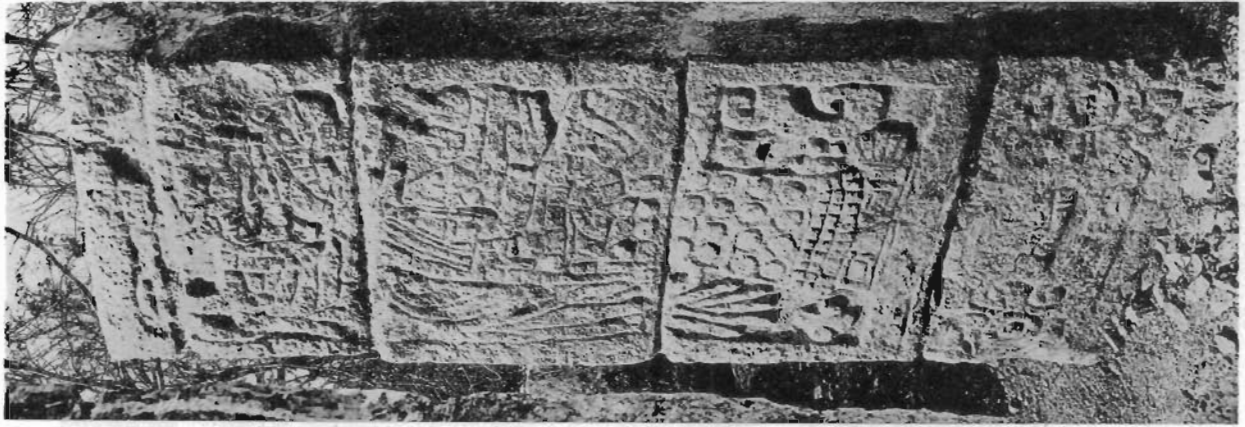
FIG. 134—STRUCTURE 3D13 (XTOLOC TEMPLE).
a: North jamb doorway of outer chamber. b: South jamb doorway of outer chamber. c: North jamb doorway of shrine room. d: South jamb doorway of shrine room.

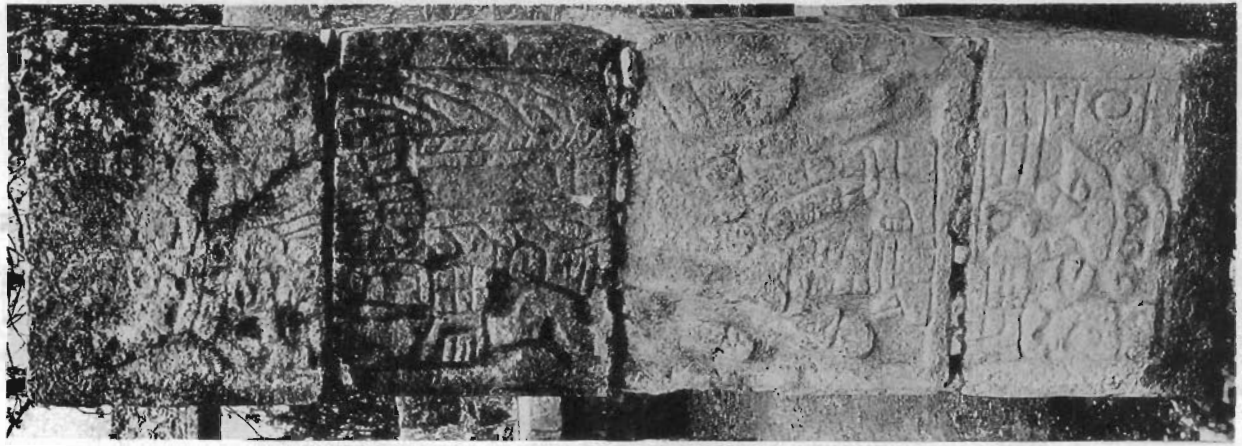
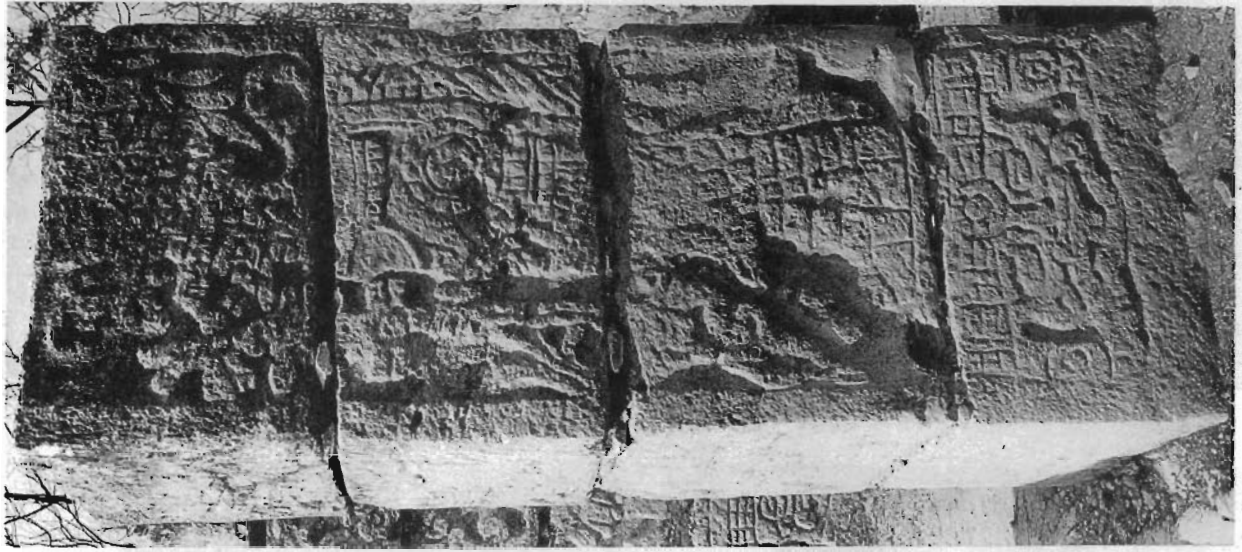
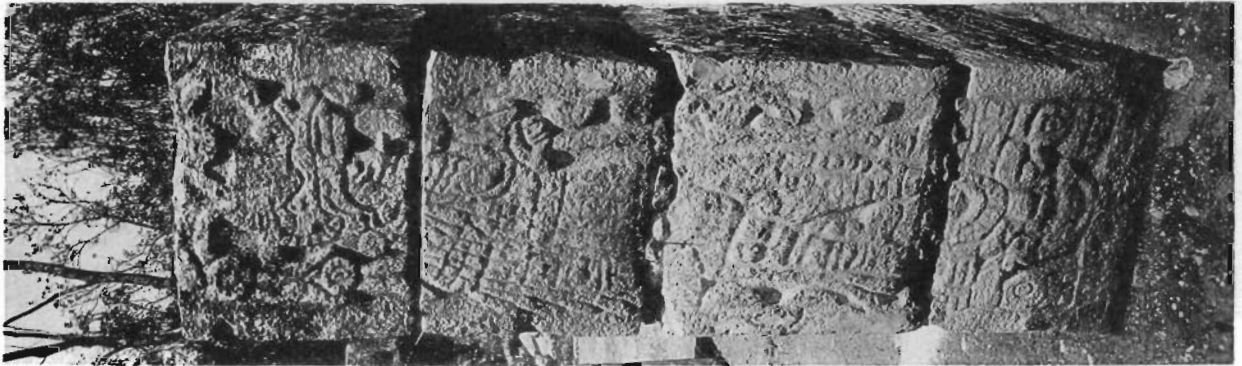
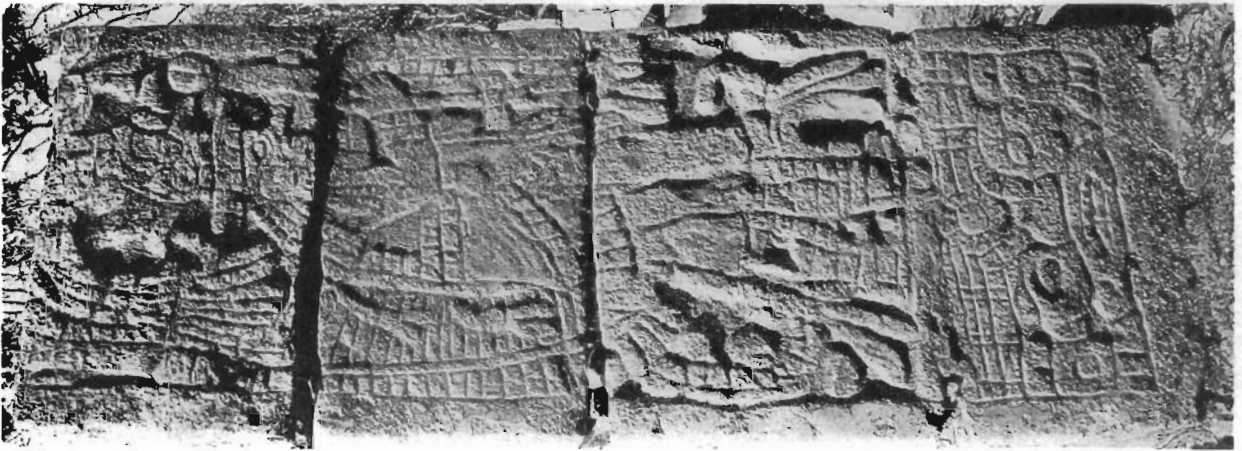
FIG. 135—STRUCTURE 3D13 (XTOLOC TEMPLE), NORTH COLUMN
a: North face. *b*: East face. *c*: South face. *d*: West face.

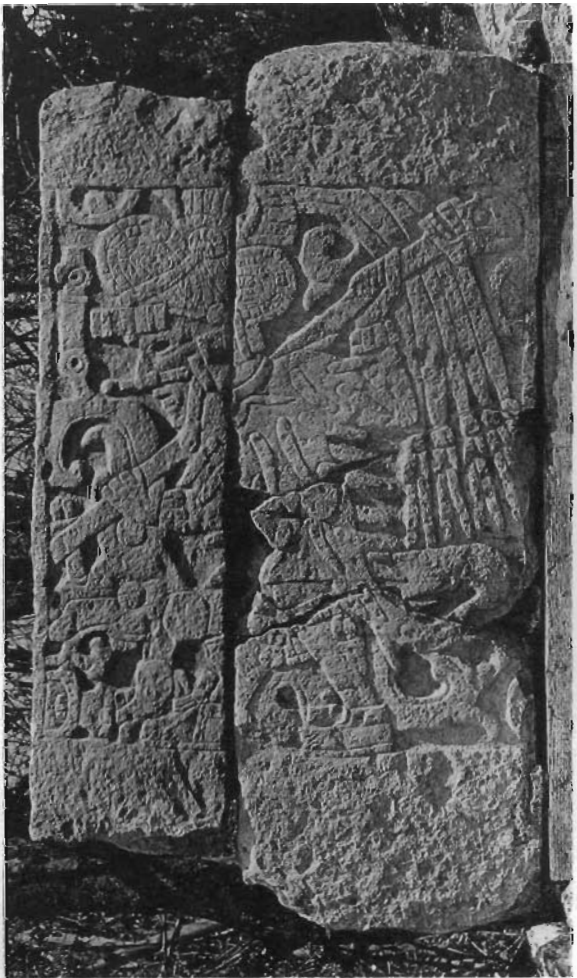
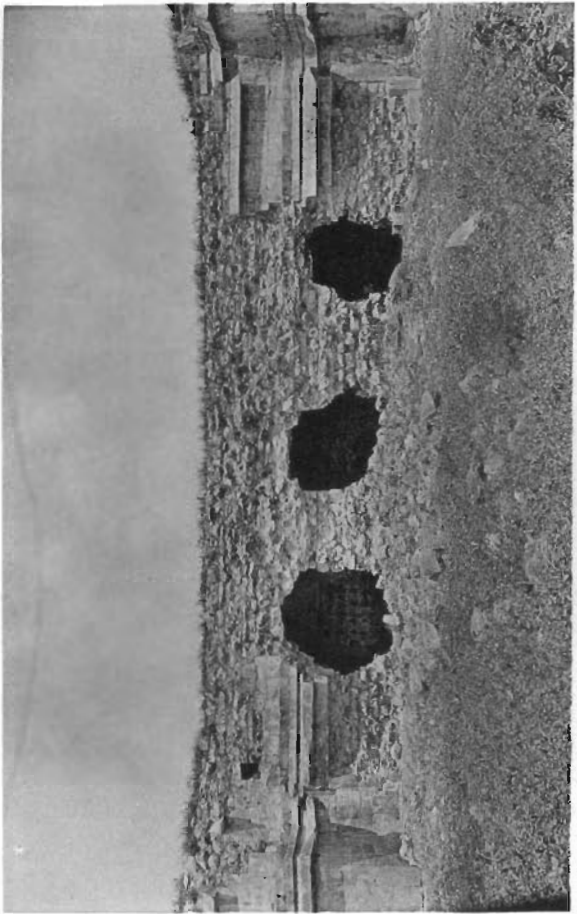
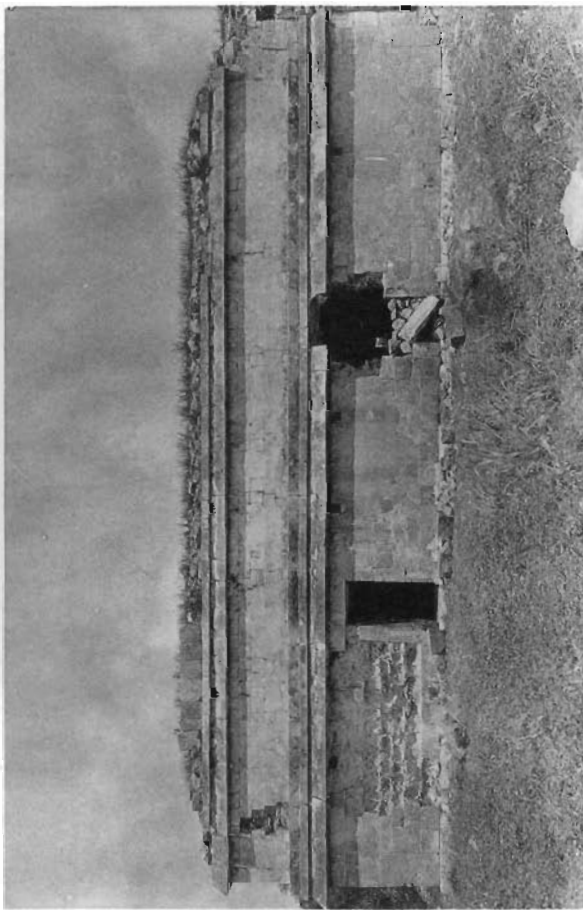
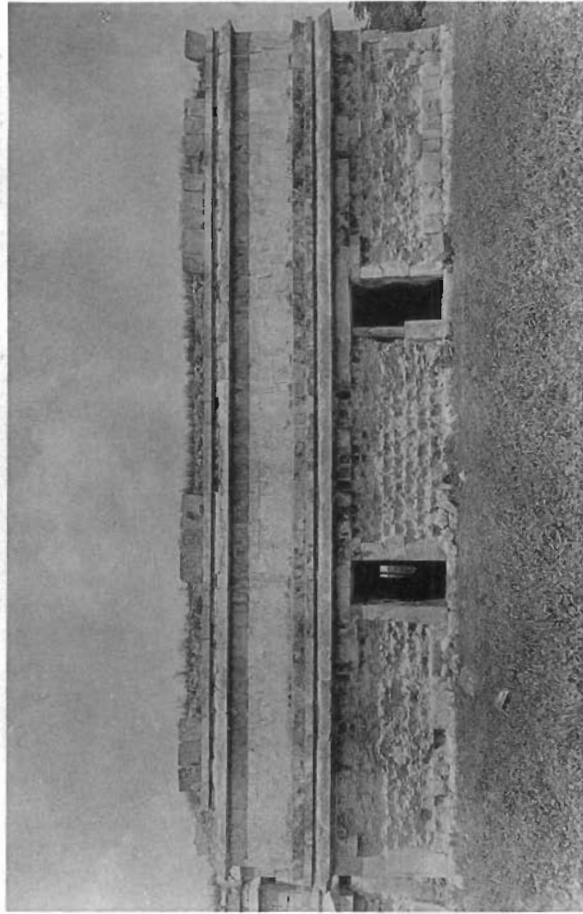
FIG. 138—STRUCTURES 3E3 (SWEAT HOUSE), 3E5, AND 4B1 (TEMPLE OF THE SCULPTURED JAMBS)
a: Str. 3E3, northeast exterior after repair. *b*: Str. 3E3, view from south looking into gallery and steam chamber. *c*: Str. 4B1, north jamb and north column. *d*: Str. 3E5, serpent columns. Horizontal portion of one capital recovered.
