CHICHEN ITZA

ARCHITECTURAL NOTES AND PLANS

Karl Ruppert

Publication 595

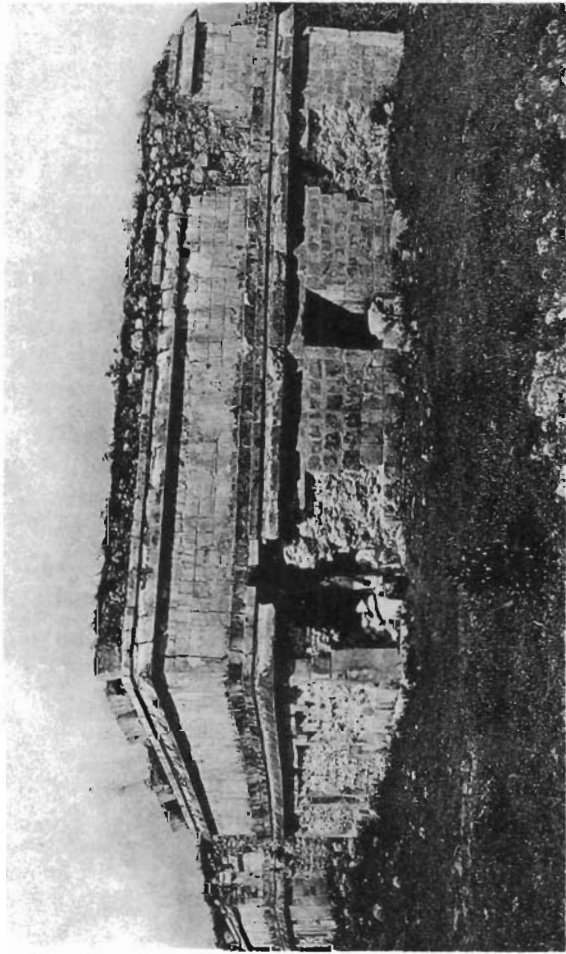
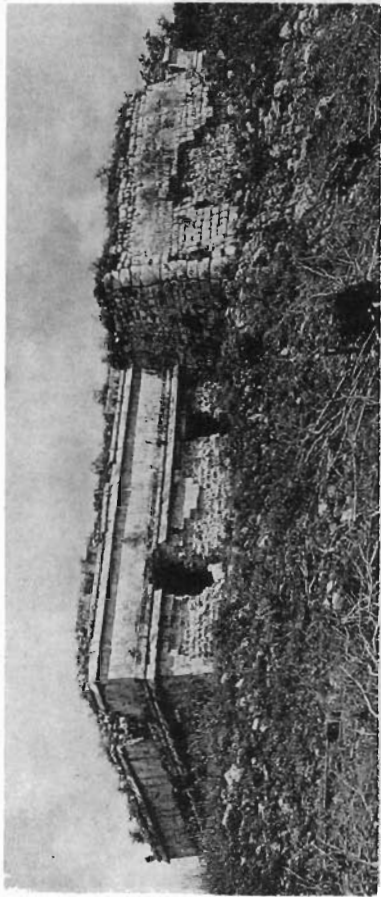
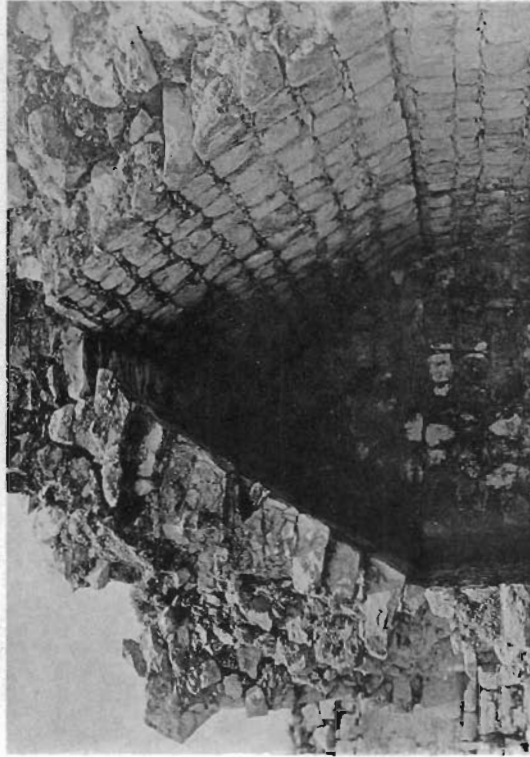
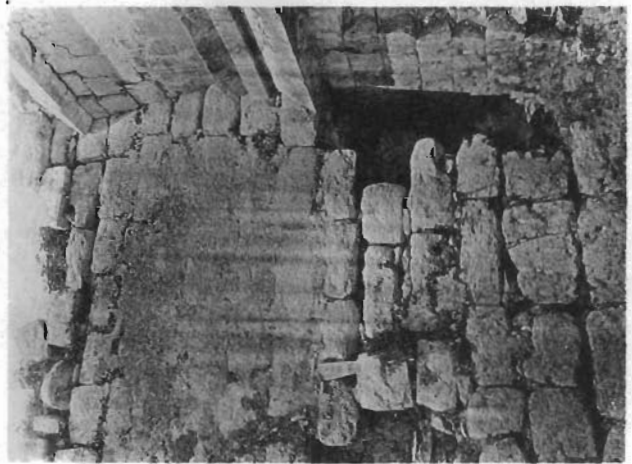
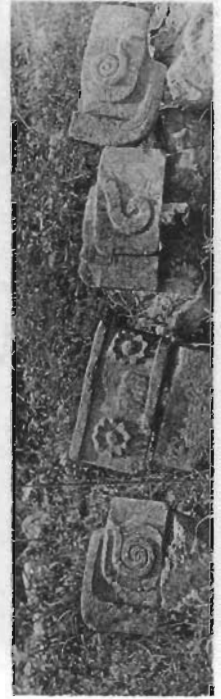
FIG. 139—STRUCTURES 4B3 AND 4D1 (AKABDZIB)
a: Str. 4B3, sculptured lintel. *b*: Str. 4D1, Central Section, west side. *c*: Str. 4D1, North Wing, west side. *d*: Str. 4D1, South Wing, west side.

Condition: Facing stones of west façade fallen or removed from lower zone and from upper zone except at ends (fig. 139,b). East wall of south chamber broken through prior to 1924 exposing east façade, which seems to be in good condition protected by fill of masonry core to east.

Condition: They are similar in arrangement and construction and no doubt contemporaneous. The South Wing better preserved than North. Much of facing stones of west and east lower zones of South Wing removed prior to 1889, as shown in Maudslay's pl. 18a, vol. 3. Some stones removed on south (figs. 139,d; 140,a). West façade of North Wing better preserved than South (fig. 139,c). The northeast corner has collapsed.

wings (fig. 139,b). Exploratory tunneling, before 1924, through north end of Room 7 into the great core shows a solid fill with much mortar for a distance of 2.18 m.; beyond this is loose open fill. The fill of the great core directly east of Room 9 (of the central chambers) has some mortar but not as much as seen in the tunnel at north end of Room 7.

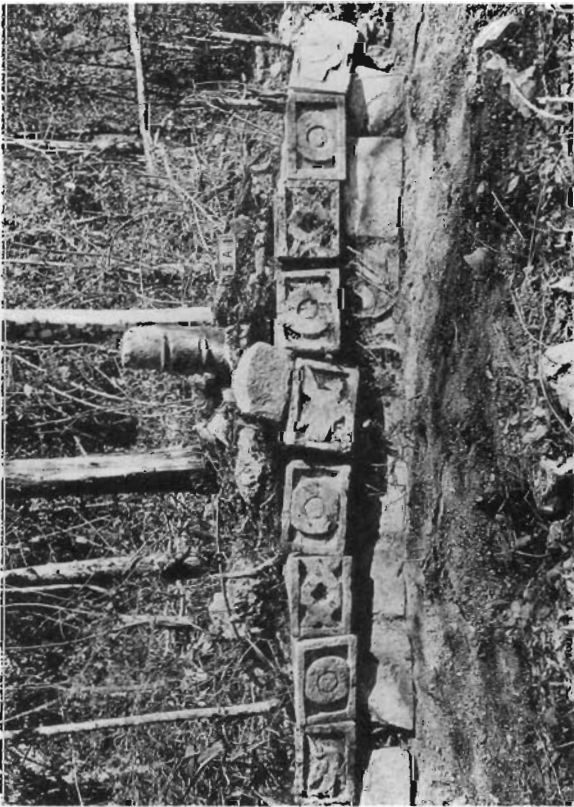
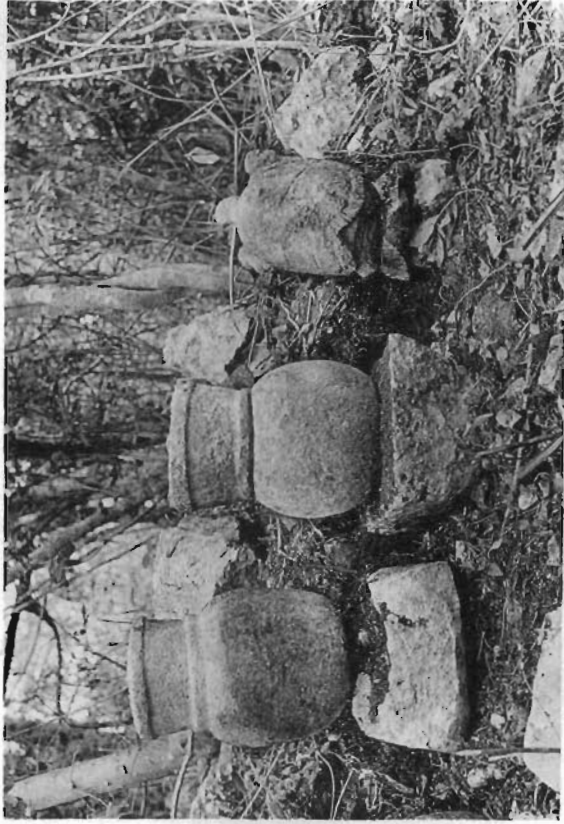
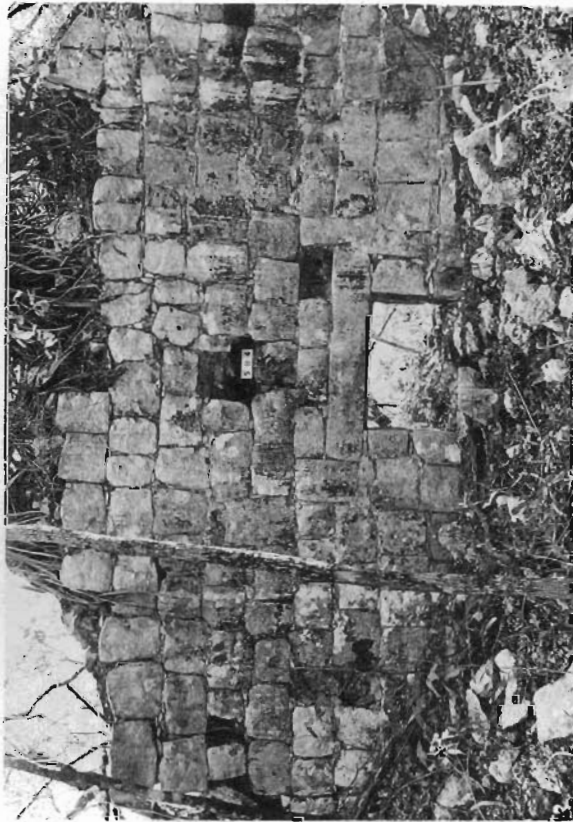
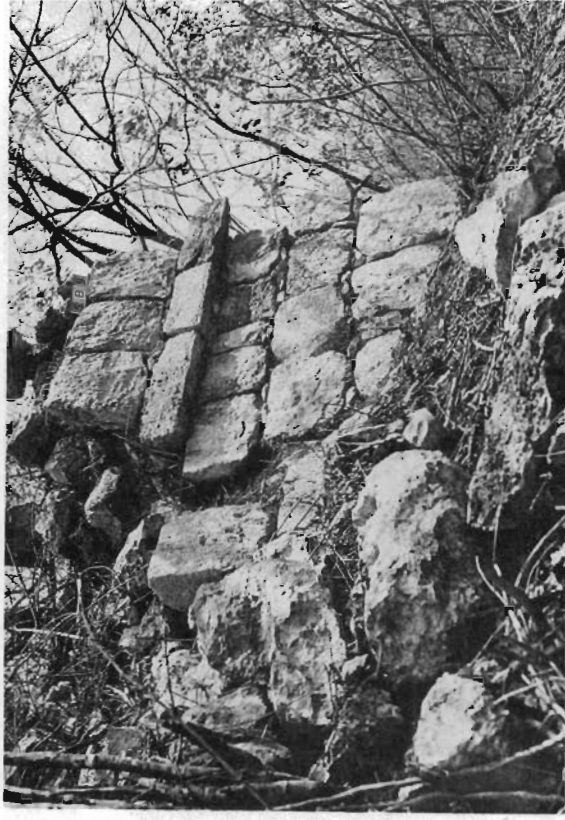
FIG. 140—STRUCTURE 4D1 (AKABDZIB)
a: South Wing, south façade. b: View at northeast where Central Section abuts North Wing. c: East side of South Wing and masonry of Central Section. d: South end of Room 16. e: Sculptured stones found on roof of Central Section.

Stones not veneer type (fig. 140,d). The first course always large and well faced. Stones seem to decrease in size and in care of finishing from lower courses

Construction: Facing of east projection of large, roughly faced stones. Courses quite regular (fig. 140,c). Quoins rounded. Individual stones large, tenons long. Facing abuts lower zone of wings. Moldings and facing of upper zone of wings abuts that of central core (fig. 140,b). On west where central chambers join the wings the masonry is of well cut, carefully faced stones similar to that of the

Sculptured lintel between Rooms 1 and 2 (Maudslay, vol. 3, pl. 19). Traces of black hatched lines on west end wall of vault Room 1. Red painted hands on interior walls (Willard, 1933, facing p. 272). Four sculptured stones on roof (fig. 140,e).

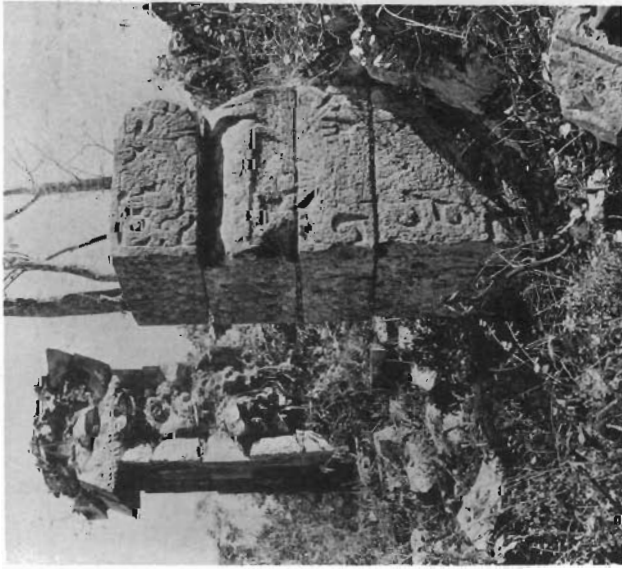
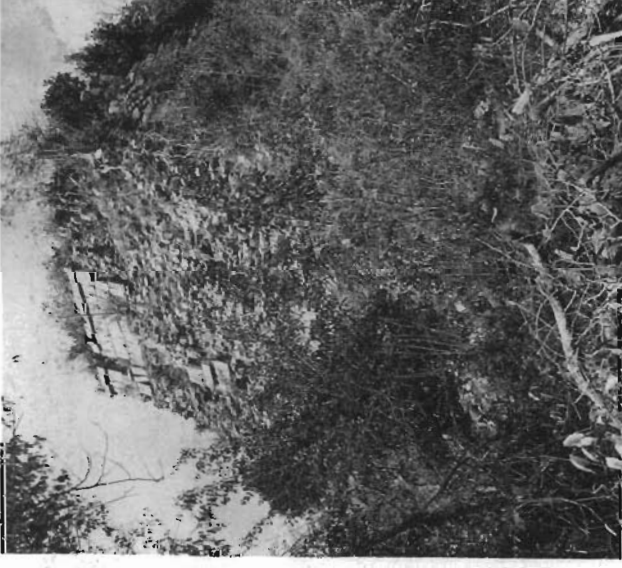
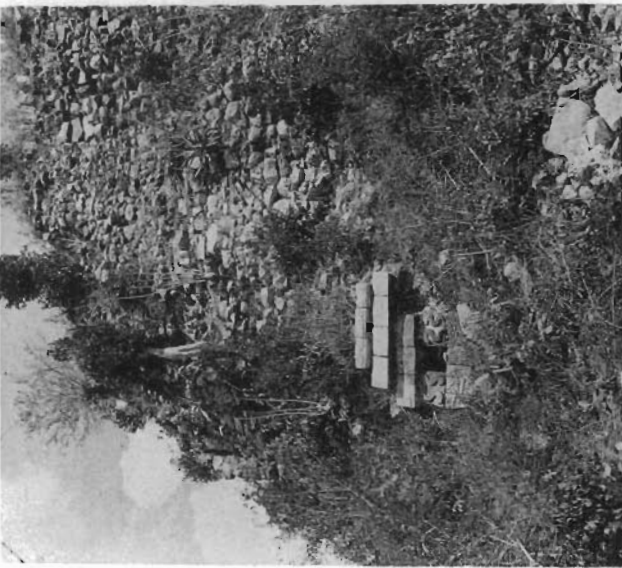
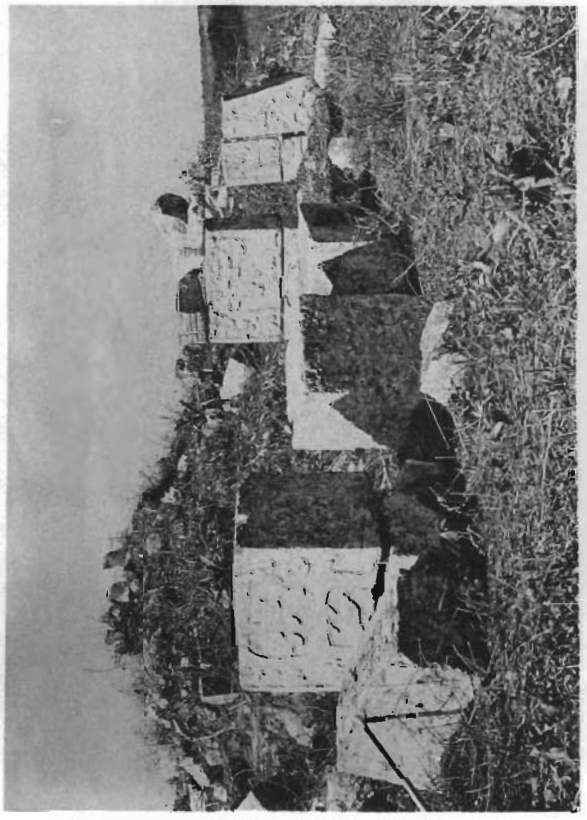
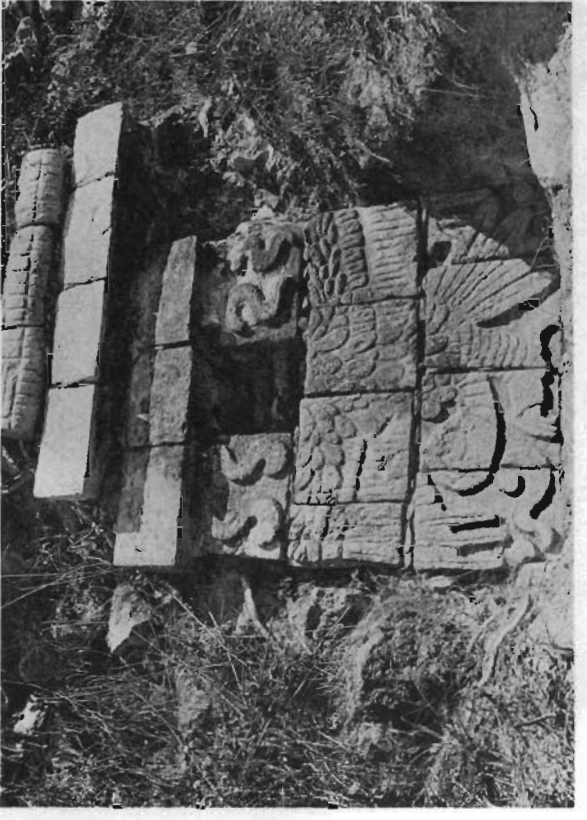
FIG. 141—STRUCTURES 5A1 (THE COLONNADE WITH THE BIRD CORNICE), 5A3, 5B2 (TEMPLE OF THE TURTLE), 5B4, AND 5B9
 a: Str. 5A1, south end. Sculptured band-molding with bird, disk, and chevron motifs. In background is sculptured colonnette from Str. 5A3. b: Str. 5B2, urn and turtle motifs from façade. c: Str. 5B4, north face of interior wall and vault soffit. d: Str. 5B9, façade of building, west side.

On north talus an elaborated colonnette 47 cm. long (fig. 141,*a*). Cornice stone 49 cm. high.

above soffit of lintel. No offset at spring line. Beam holes in vault arranged in pairs 1.75 m. apart and 28 cm. above spring line. In Room 3 the vault rises 1.45 m. with five courses (fig. 141,c). Vault stones veneer type. Lintel of doorway between Rooms 2 and 3 of two stones. No vault in position above this doorway.

Façade: Rises 1.05 m. with basal batter, followed by 17-cm. triangular molding. Vertical wall above is 75 cm. thick. Masonry very rough, possibly because of weathering (fig. 141,d). Triple entrance, two

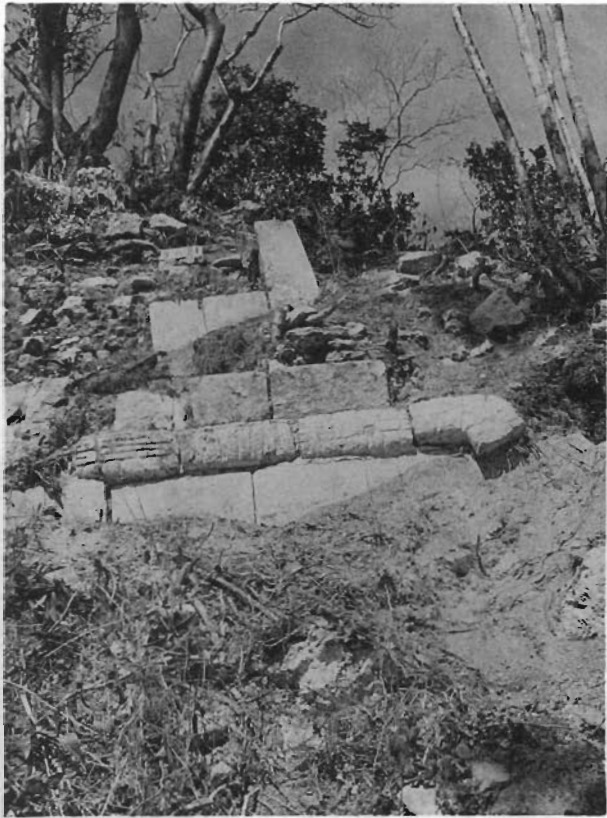
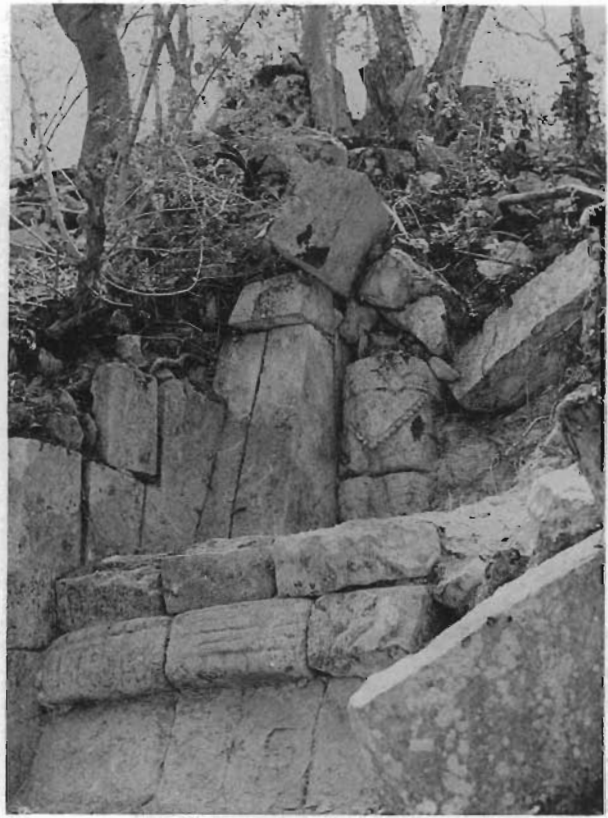
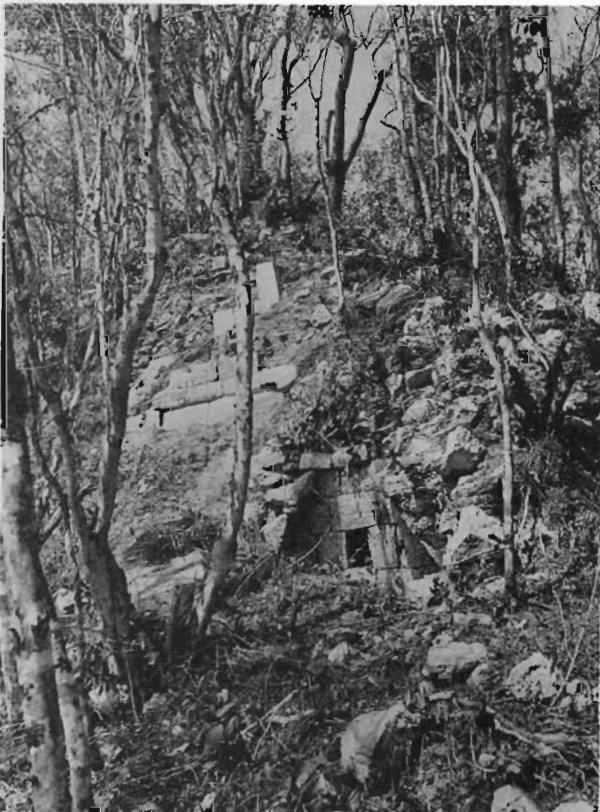
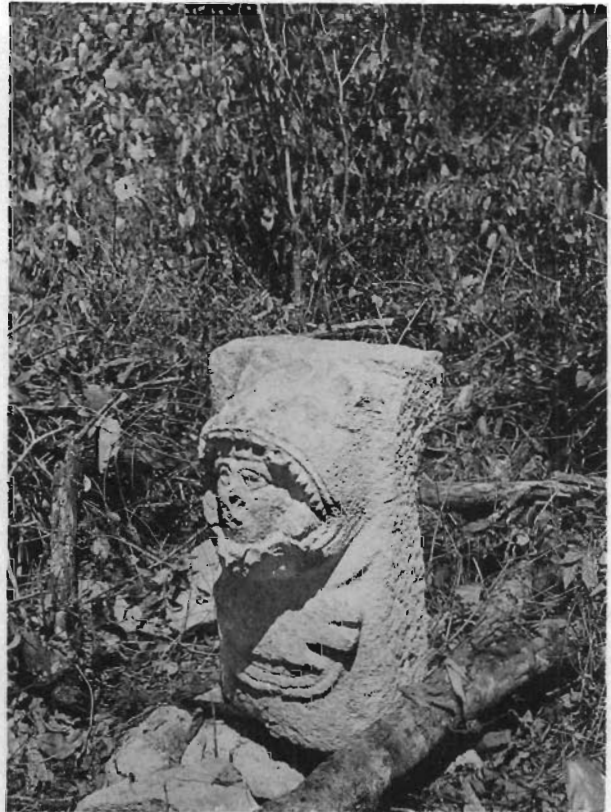
FIG. 142.—STRUCTURES 5B16 AND 5B18 (CASTILLO OF OLD CHICHEN)
 a: Str. 5B16, sculptured column in entrance and standing section of west wall. b: Str. 5B18, south side. At top of pyramid is seen battered lower zone of temple. c: Str. 5B18, west side of pyramid. d: Str. 5B18, sculptured stones at entrance to temple. e: Str. 5B18, sculptured eagle panel on west side of pyramid.

probable three-member molding. The masonry exposed is block-like, carefully faced, no chinking (fig. 142,a). Triple entrance, columns 75 cm. square, 2.80 m. high, sculptured with human figures on four sides. Jambs sculptured.

Facing: Seemingly rose in a number of ornamented zones, probably four (fig. 142, b, c). A section of second zone on west side shows a battered face ornamented with sculptured eagle figure in 1.16-m. panel, recessed 13 cm. The area at either side of the panel seems to be plain. Above the battered face are two apron moldings topped with a serpent band (figs. 77, b; 142, e).

Facade: Basal batter rises 1.25 m. (fig. 142, b). This topped with 24-cm. apron molding. Triple entrance, columns 64 by 43 cm., sculptured with plant motif. Jambs similarly sculptured (fig. 142, d).

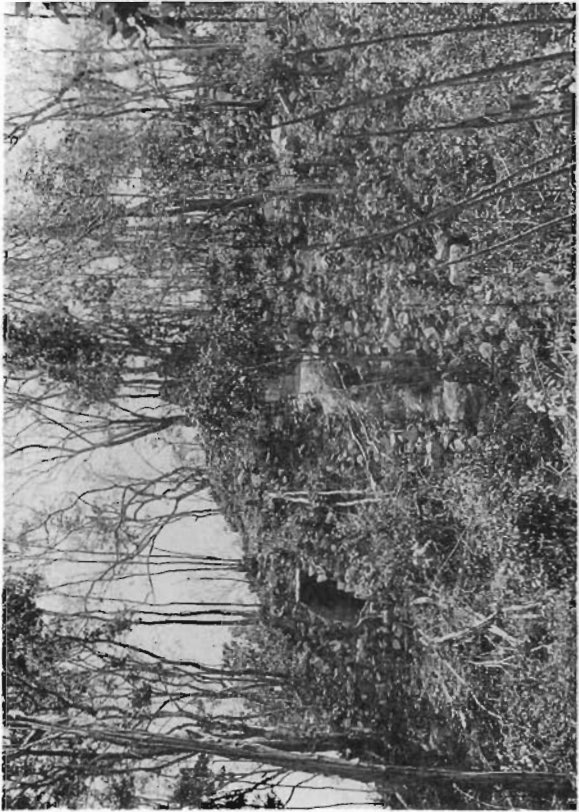
a: Serpent band as ornament on east side at top of pyramid facing. *b*: Temple entrance. East jamb. Portion of Atlantean figure which served as pilaster. *c*: Remains of chamber at east base of pyramid. *d*: Head of jaguar Atlantean figure.

Facing: Probably rose in four zones. Small sections of facing seen on east side, and on north below east jamb of temple entrance (fig. 143,a,b). This represents uppermost zone. Rises with batter and topped with serpent band and triangular cornice. The serpent band probably extended around the pyramid as stones of such a band noted in debris on south talus. On the north side the facing seemingly rose from roof of colonnade.

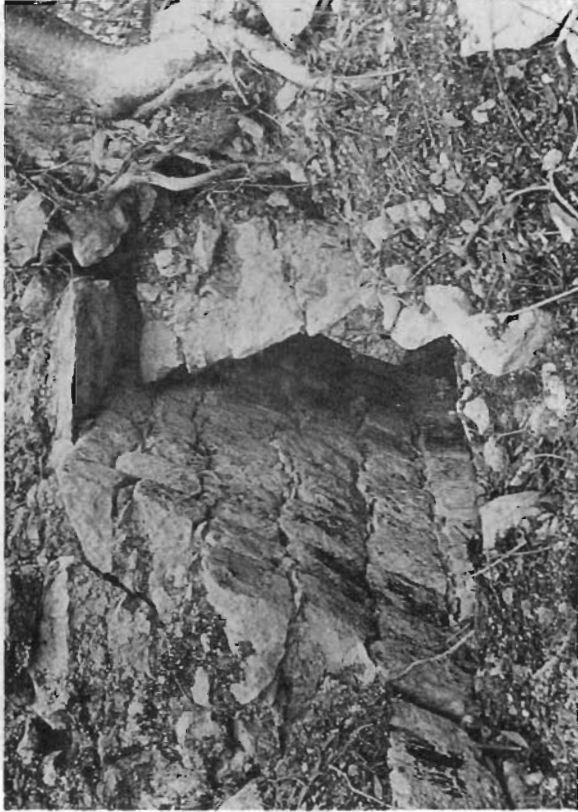
c

FIG. 144—STRUCTURES 5B21 (TEMPLE OF THE JAGUAR ATLANTIC COLUMNS) AND 5B22
a: Str. 5B21, north side. Portion of passageway seen at left. *b*: Str. 5B22, east end of passageway. *c*: Str. 5B22, west end of passageway.
d: Str. 5B22, west end of passageway and blocked doorway leading into gallery of Str. 5B17.

On north side of building at west is a secondary passageway, 4.50 m. long, 1.05 m. wide (fig. 144,*b*). In construction of passageway the two upper members of the medial molding of façade of the building were removed. The vault of the passageway springs

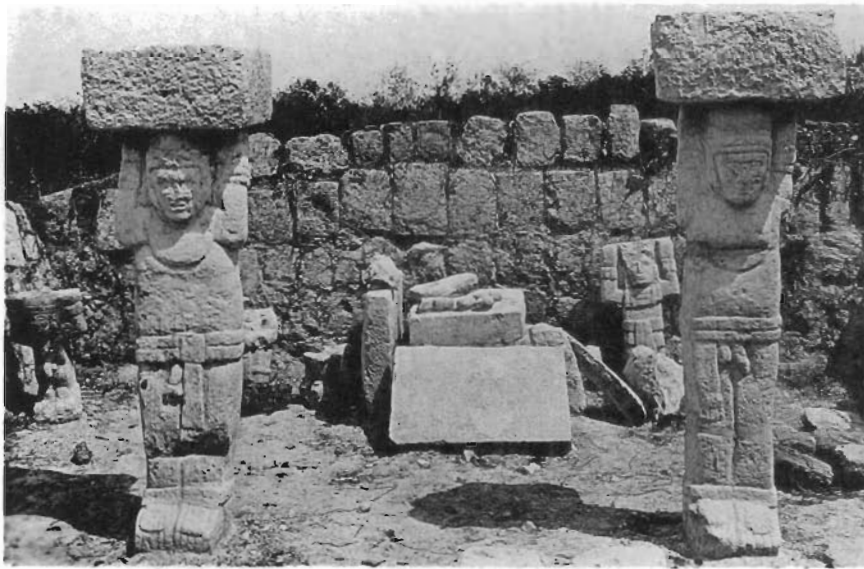
a

FIG. 145—STRUCTURES 5C3 (TEMPLE OF THE LITTLE HEADS) AND 5C5 (TEMPLE OF THE SNAILS)
a: Str. 5C3, interior. *b*: Str. 5C3, one of two heads found in chamber. *c*: Str. 5C5, snail figure from band molding. *d*: Str. 5C5, northeast exterior. *e*: Str. 5C5, southeast exterior.

served as vault supports. Height of columns with capitals is 1.77 m. (fig. 145,a). Veneer-type vault stones.

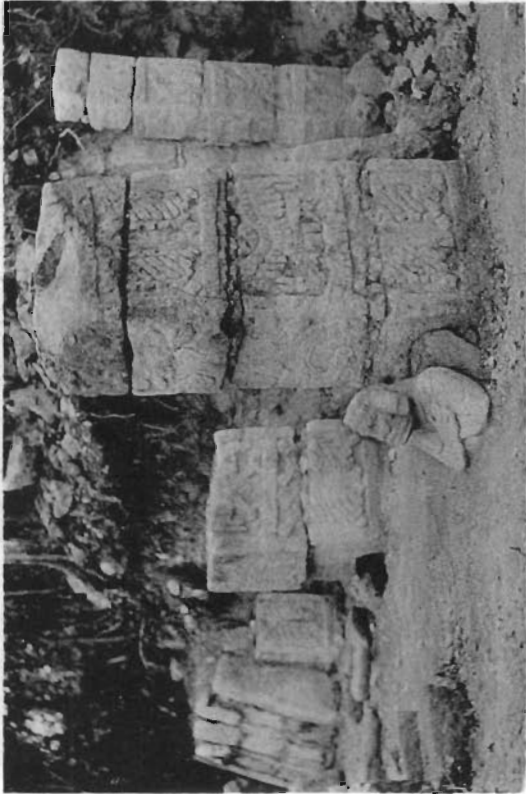
a

FIG. 146—STRUCTURES 5C7 (TEMPLE OF THE OWLS), 5C10, 5C12, AND 5C14 (HOUSE OF THE PHALLI)
a: Str. 5C7, north entrance with figure tenoned in base of column. *b*: Str. 5C10, mouth of chultun. *c*: Str. 5C12, chac moai. *d*: Str. 5C14, south side.

Stone found tenoned in base of west column sculptured in form of torso and head (fig. 146, *a*).

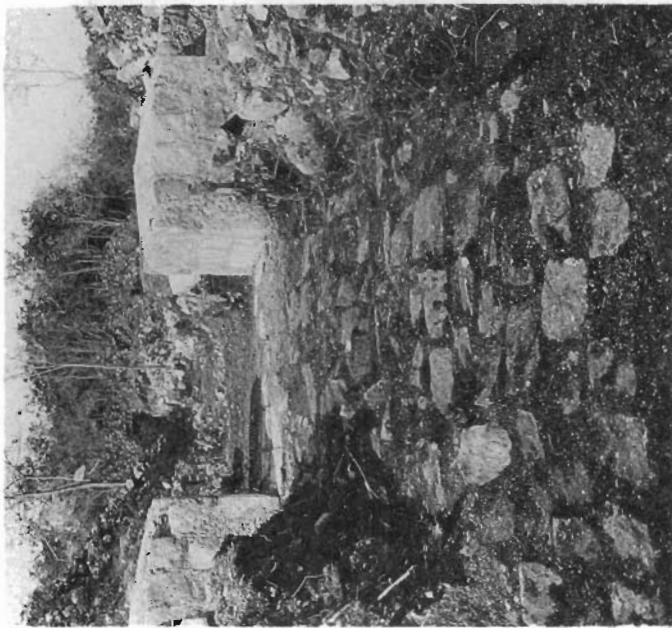
a

FIG. 148—STRUCTURES 5C15 (TEMPLE OF THE ATLANTEAN COLUMNS), 5C16 (PORTAL VAULT), 5C17, 5D1, 6B2, AND 7B3 (TEMPLE OF THE THREE LINTELS)
a: Str. 5C16, north entrance to Initial Series Group. *b:* Str. 7B3, vault stone. *c:* Str. 5C15, Atlantean columns excavated in 1926.
d: Str. 5C17, iguana figure. *e:* Str. 5D1, serpent head at base of pyramid. *f:* Str. 6B2 North, miscellaneous sculptured stones found on surface.

Walls: Great blocks of masonry 2 m. apart. Average 1.52 m. wide, 1.85 m. long. Now rise 1.06 m. (fig. 148,a).

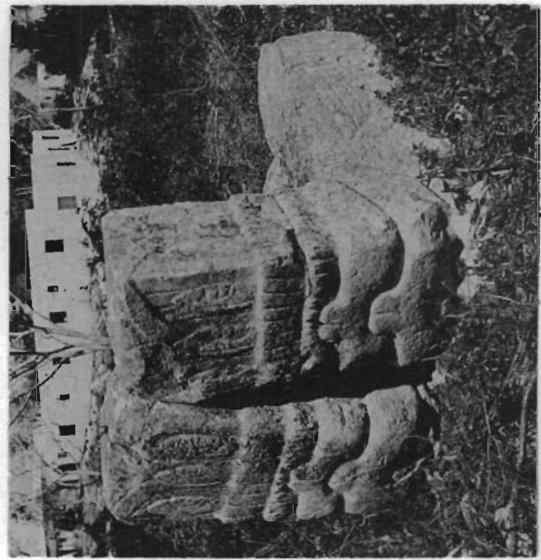
e

FIG. 150—STRUCTURE 7B4 (TEMPLE OF THE FOUR LINTELS) AND MISCELLANEOUS SCULPTURE
a: Str. 7B4, doorways on north side. *b*: Str. 7B4, east side of inner doorway. *c*: Chultun Group, sculptured column. *d*: Str. 7B4,
 incensarios. *e*: Two tails of serpent columns abandoned in bush.

FIG. 109—STRUCTURE 7B4, PLAN
(See figs. 149,e; 150,a,b,d.)
